**Squeaks & Rattles – Airbag Door  
and Fascia Noise – Repair Procedure**MODEL 1995 MY  
Sedan RangeVIN  
720001-747133**ISSUE:**

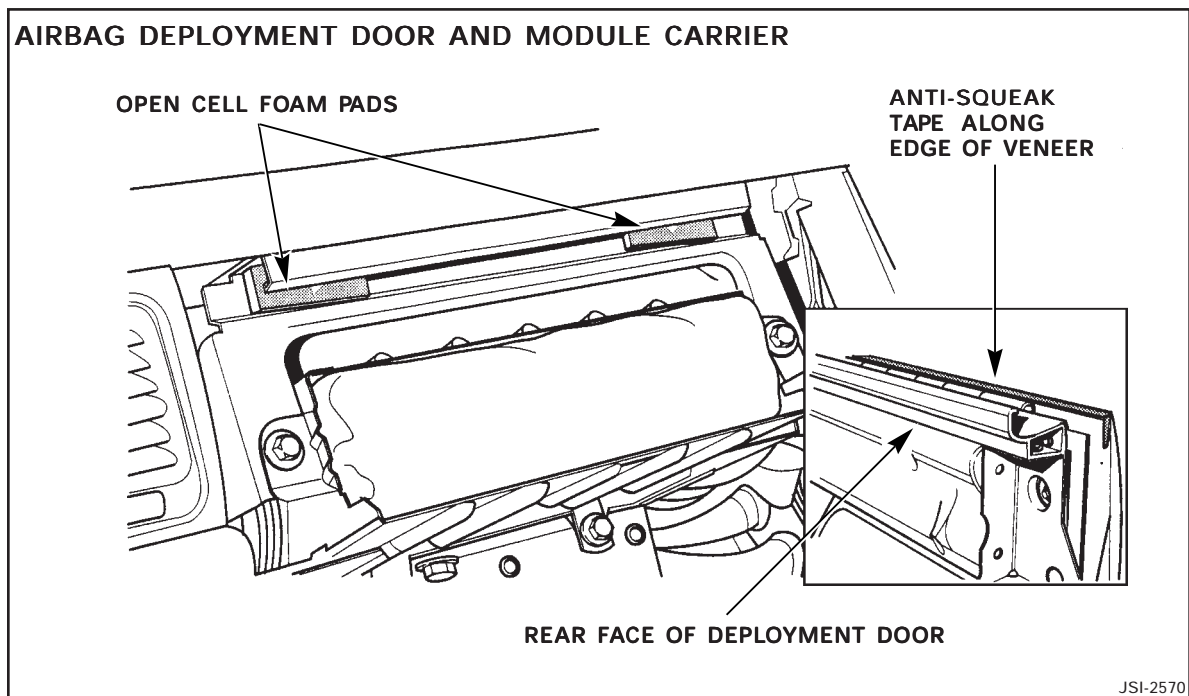
ILLUSTRATION 1

Some 1995 MY Sedan Range vehicles within the above VIN range may experience squeaking from the air bag door rubbing against the adjacent fascia panel veneer, or the rear face of the door rubbing against the Airbag module carrier assembly. The noise from the deployment door and the fascia panel veneer can be eliminated by applying anti-squeak tape along the edge of the veneer, applying foam pads to the airbag module carrier assembly (Illustration 1), and realigning the airbag deployment door (Illustration 2).

4. Apply anti-squeak tape (5 mm wide) along the top edge of the deployment door veneer (Illustration 1). Make sure the tape overlaps the ends as shown.
5. Attach two pads of open cell foam to the airbag module carrier assembly (Illustration 1) to prevent contact with the door assembly. The pads were introduced in production from VIN 741674.

**NOTE:** Position the pads so they will not be visible to the vehicle occupants.
