Sedan Range

19.5-04

TECHNICAL BULLETIN

Squeaks & Rattles – Noise from Console Veneer & Trim – Install Anti-squeak Tape

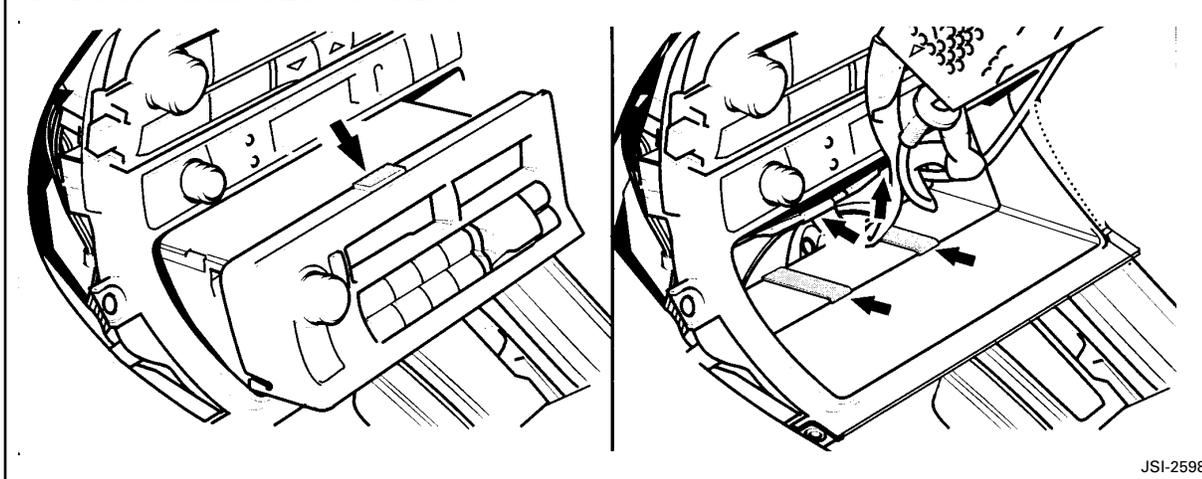
ILLUSTRATION 1

APPLYING FOAM PADS TO RADIO

12. Depress the clips and pull out the radio using care not to damage the surrounding area. It is not necessary to disconnect the radio.
13. Cut a 10mm x 20mm piece of closed cell foam pad and apply it to the top edge of the radio fascia behind the front lip (Illustration 1).
14. Hold the cardboard in place and reinstall the radio.
15. Reinstall the console switch panel using care not to pinch the harness wires.
16. Apply 5mm wide anti-squeak tape to the left, right and front outer edges of the console veneer panel (Illustration 2). Do not apply tape to the front outer edge.
17. Apply 5mm anti-squeak tape to the inner edge of the panel (Illustration 2). Do not apply tape to the inner edge of the J-gate opening.

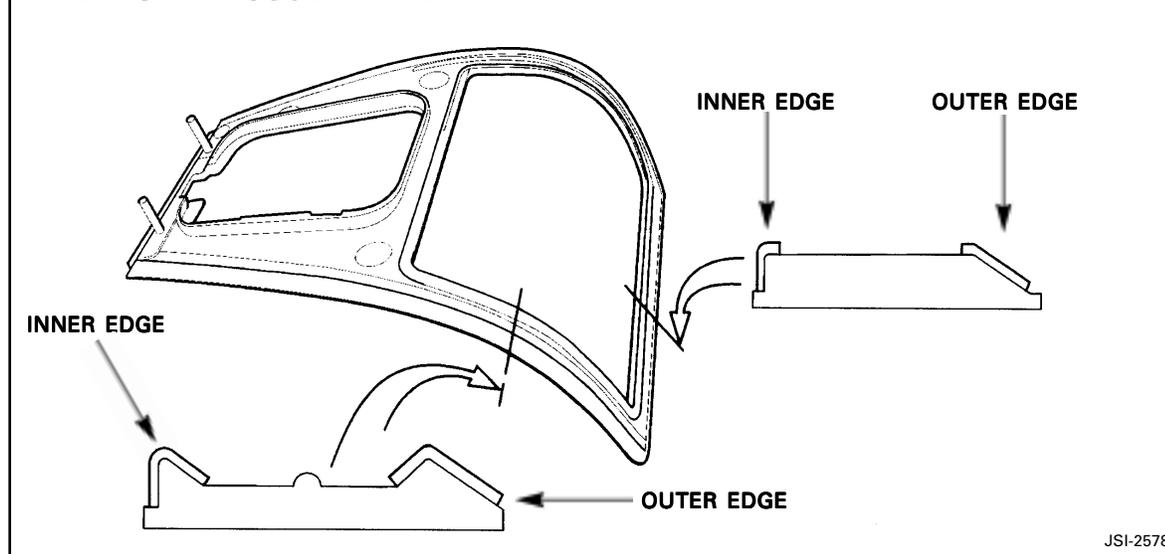
ILLUSTRATION 2

APPLYING ANTI-SQUEAK TAPE
