19.5-04

TECHNICAL BULLETIN

Squeaks & Rattles – Noise from Console Veneer & Trim – Install Anti-squeak Tape

MODEL 1995 MY
Sedan Range
VIN 720001-740940

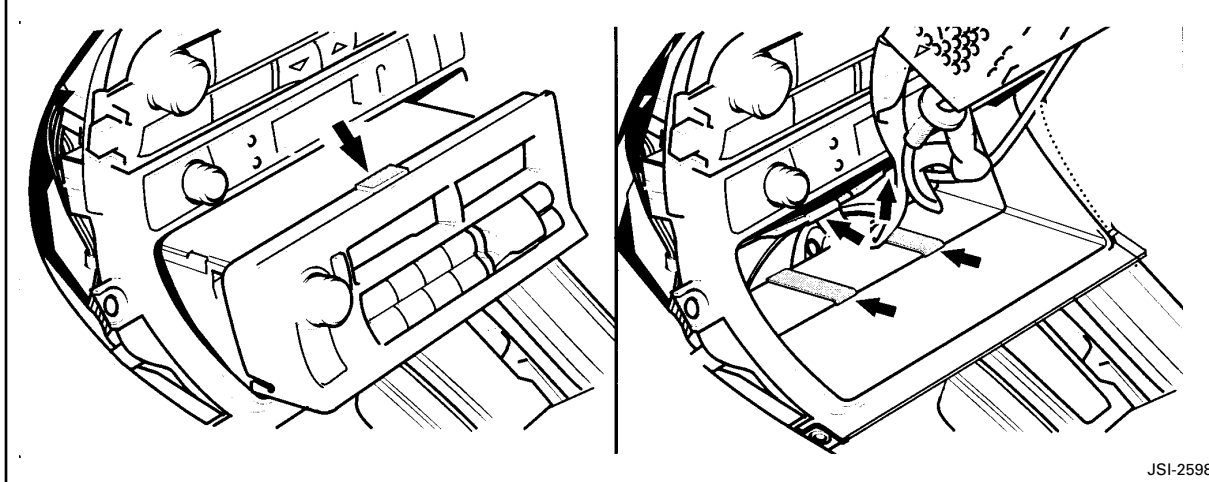
ILLUSTRATION 1

Some 1995 MY Sedan Range vehicles within the above VIN range may exhibit a noise from the center console area.

APPLYING FOAM PADS TO RADIO

12. Depress the clips and pull out the radio using care not to damage the surrounding area. It is not necessary to disconnect the radio.
13. Cut a 10mm x 20mm piece of closed cell foam pad and apply it to the top edge of the radio fascia behind the front lip (Illustration 1).
14. Hold the cardboard in place and reinstall the radio.
15. Reinstall the console switch panel using care not to pinch the harness wires.
16. Apply 5mm wide anti-squeak tape to the left, right and front outer edges of the console veneer panel (Illustration 2). Do not apply tape to the front outer edge.
17. Apply 5mm anti-squeak tape to the inner edge of the panel (Illustration 2). Do not apply tape to the inner edge of the J-gate opening.
