Squeaks & Rattles – Noise from Traction Control Actuator – Install Isolating Pads

MODEL 1995 MY
Sedan Range
VIN 720001 - 734054

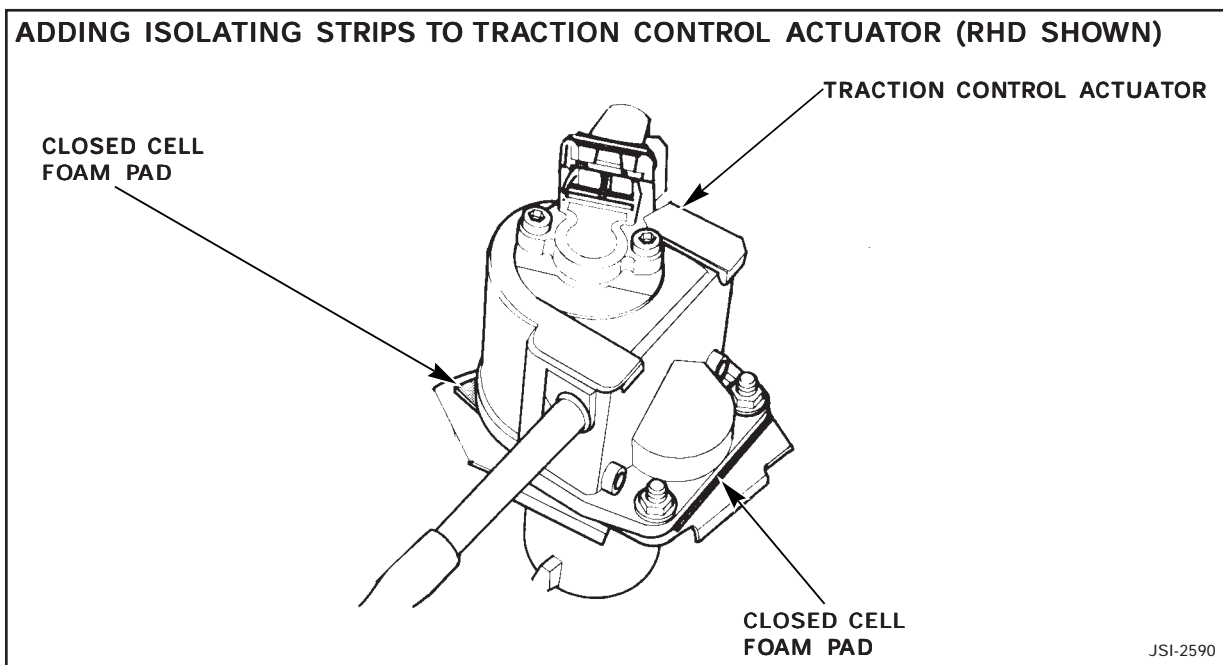
ILLUSTRATION 1

Some Sedan Range vehicles, within the above VIN range, equipped with traction control may experience a noise that the customer reports as coming from the right side of the fascia. The source of the noise may actually be in the engine compartment and be caused by vibration of the traction control actuator on its mounting.

1. Loosen the two screws that secure the traction control actuator on its mounting bracket.
2. Cut two 25/64 in. (10 mm.) wide strips from a closed cell foam pad.
3. Raise the actuator and insert the two strips between the mounting bracket and the actuator as shown in Illustration 1.
