**Squeaks & Rattles – Noise from  
PAS Reservoir – Adjust Mounting**

MODEL 1995 MY  
Sedan Range  
VIN 720001-740691

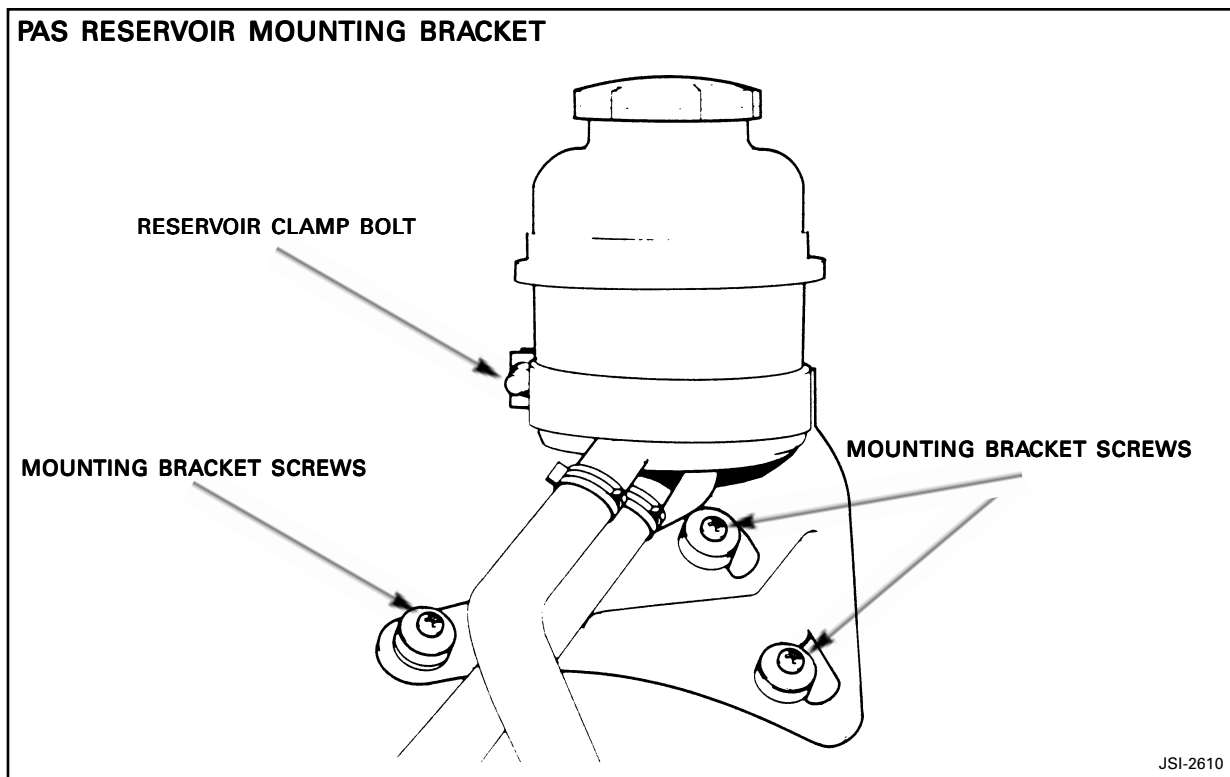
ILLUSTRATION 1

The noise can be caused by contact between the cap of the power assisted steering (PAS) fluid reservoir and the hood insulating lining.

1. Remove the toolbox assembly.
2. Loosen the clamp bolt (Illustration 1) that retains the PAS reservoir in the mounting bracket.

3. Raise the reservoir to allow access to the screws (Illustration 1) that secure the bracket to the inner fender well.
4. Loosen the mounting bracket screws.
5. Push the mounting bracket down as far as it will go. Tighten the screws while holding the mounting bracket down as far as possible.
6. Push the reservoir down into the mounting bracket and tighten the clamp bolt. The reservoir should now be seated as low as possible in the mounting bracket.
7. Reinstall the toolbox assembly.
