Sedan Range

19.6-07

TECHNICAL BULLETIN

Squeaks & Rattles – Noise From Fascia – Movement of Steering Column Upper Bracket

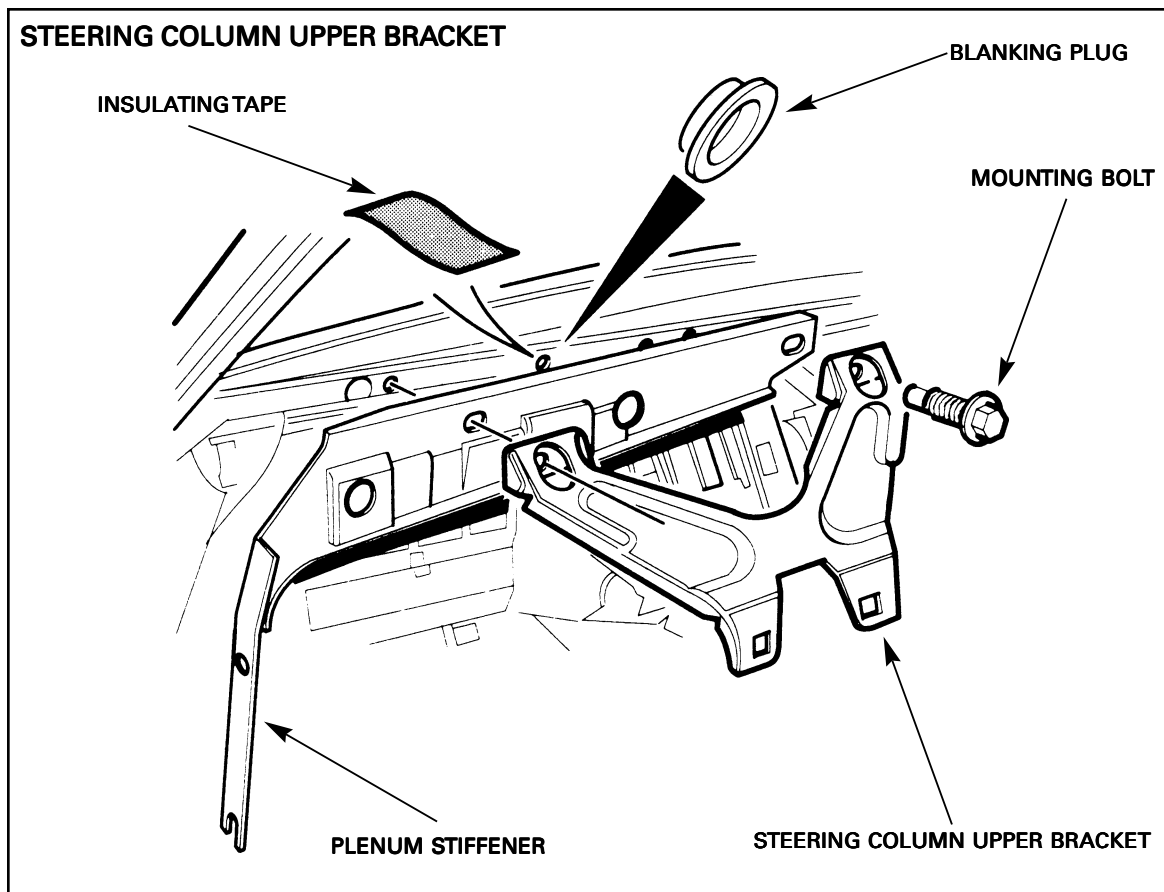
ILLUSTRATION 1

Some 1995 MY Sedan Range vehicles within the above VIN range may exhibit a noise that appears to come from the instrument area. The noise may be caused by movement of the steering column upper bracket against the plenum stiffener, Illustration 1, and the surface of the plenum.

The upper mounting bracket can move if it is not in full contact with the surface of the plenum. Blanking plugs or excess hardened sealer can prevent full contact thereby allowing movement.

11. Remove the retaining bolts and move the stiffener to obtain access to the plenum, Illustration 1.
12. Remove and discard the blanking plugs from the unused holes in the plenum (Illustration 1). Cover the holes with lengths of insulating tape to keep them air tight.

13. Clean any excess sealer from the surface of the plenum around the area of the mounting bolt weld nuts. This area should be flat without any projections.

16. Lift the steering column assembly from the temporary support and loosely attach the upper mounting bracket and the plenum stiffener to the plenum using new bolts. Do not final tighten the bolts.

18. Center the steering column with the instrument cluster and tighten the new bolts that secure the upper mounting bracket to the plenum to 17-23 Nm.
19. Clip the wiring harness connectors to the steering column bracket.
