Sedan Range

19.7-03

## TECHNICAL BULLETIN

### Knocking from Front Suspension – Shock Absorber Mounting – Repair Procedure

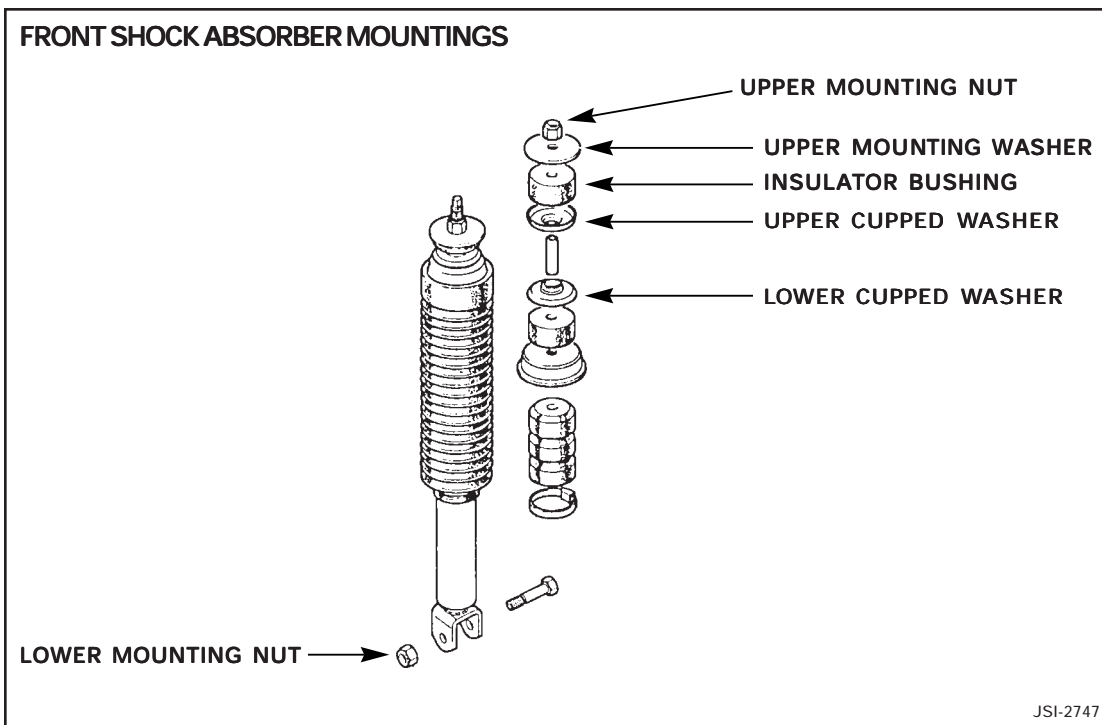
ILLUSTRATION 1

Some 1995-96 MY Sedan Range vehicles may experience knocking noises from the front shock absorbers.

2. Check that the shock absorber upper cupped washer (Illustration 1) is fully seated against the inner fender panel in the engine compartment.
3. Remove the upper mounting nut (Illustration 1) and remove the upper mounting washer and insulator bushing.
4. Inspect the cupped washer. If the washer is distorted or damaged in any way, install a new cup washer (part no. CBC 5431). Reassemble the bushing and cup washer, ensuring that the cup washer is correctly seated against the body. Always install a new nut (part no. JZN 100013) and torque to 26 lb. ft. (35 Nm).
5. Repeat steps 1-4 on the opposite side of the vehicle.
6. Reinstall components removed in step 1.

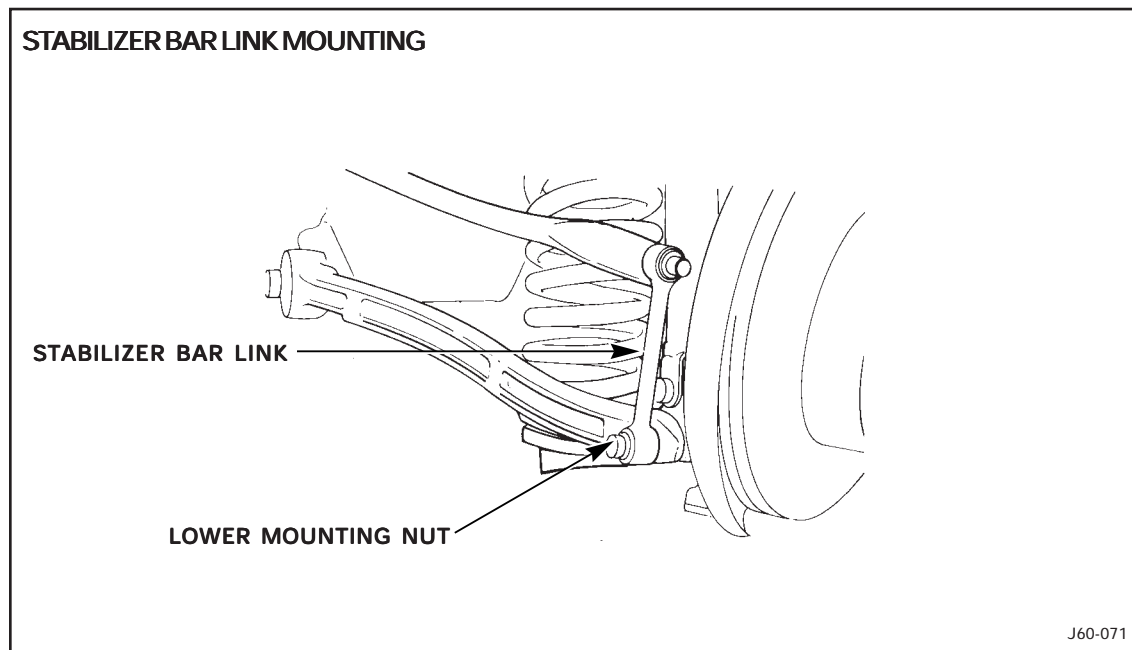
ILLUSTRATION 2

To overcome concerns of knocking noises from the lower shock absorber mounting, the torque specification for the mounting nut has been raised to 51.6 lb. ft. (70 Nm) from VIN 777889.

1. After performing the above inspection, raise the vehicle on a lift so the front suspension hangs fully extended.
2. Remove the mounting nut (Illustration 2) from the lower mounting of the stabilizer bar link. Discard the nut. Move the link aside to allow access to the lower mounting of the shock absorber.
3. Remove and discard the existing lower mounting nut (Illustration 1) from the lower mounting bolt of each shock absorber.
4. Install a new mounting nut (part no. JZN 100013) and torque to 51.6 lb. ft. (70 Nm).

5. Reinstall the stabilizer bar link using a new nut (part no. JZN 100013) and torque to 70 lb. ft. (95 Nm).
6. Repeat steps 1-5 on the opposite side of the vehicle.
