Rattle –  
Rear of Vehicle Underbody –  
Repair Procedure

MODEL 1995-97 MY  
Sedan Range  
VIN 720001-812255

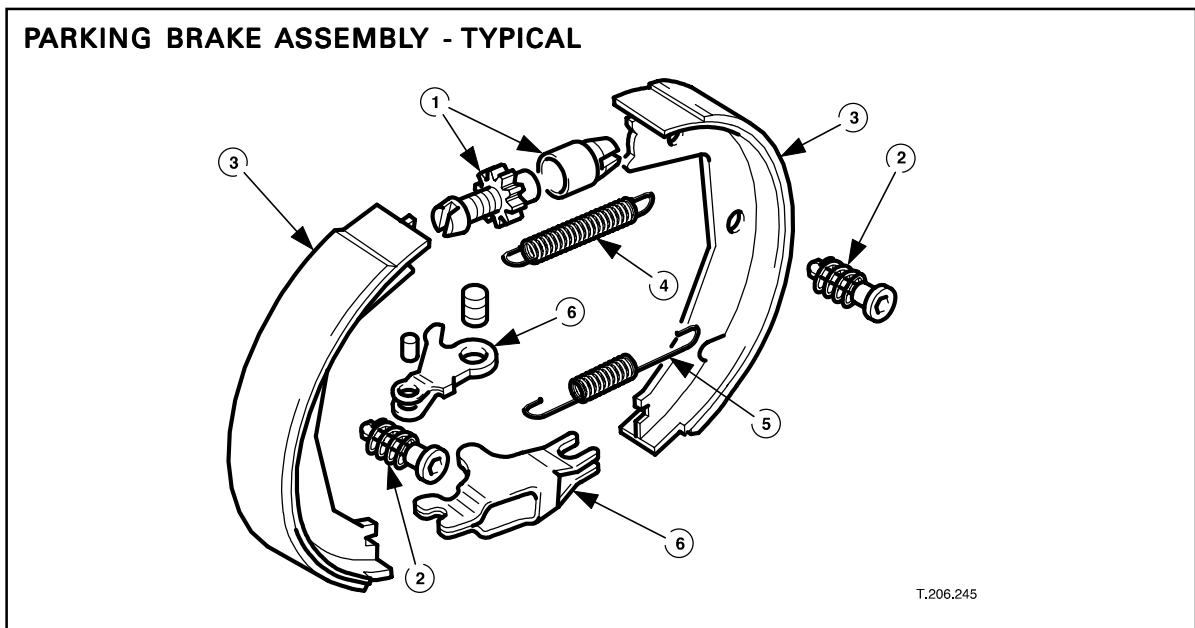
ILLUSTRATION 1

On 1995-97 MY Sedan Range vehicles, a rear-end underbody rattle may be caused by the parking brake mechanism.

Install rubber sleeves over each parking brake shoe lower return spring (Item 5, Illustration 1). The sleeves will exert pressure on the parking brake shoe spreader mechanism, to prevent it from rattling against the backing plate under certain conditions.

1. Raise and support the rear of the vehicle. Ensure that the parking brake is fully released.
2. Remove the rear wheels.
3. Disconnect the rear brake calipers, supporting them clear of the rear brake discs.
4. Without disturbing the adjustment of the parking brake shoes, remove the brake discs.
5. Release and remove the brake shoe lower return springs.
6. Slide a rubber sleeve over each spring. (See Parts Information).
7. Reinstall the springs, ensuring that the rubber sleeves are centered on each spring and that the sleeves exert a moderate pressure on the shoe spreader mechanism.
8. Reinstall the brake discs, pads, calipers and road wheels.
