V8 XJ Series/XK

303-S498

TECHNICAL BULLETIN

**“Engine Fail Safe” Displayed –
Replace Throttle Body – Normally Aspirated
Vehicles Only – Service Action S498**

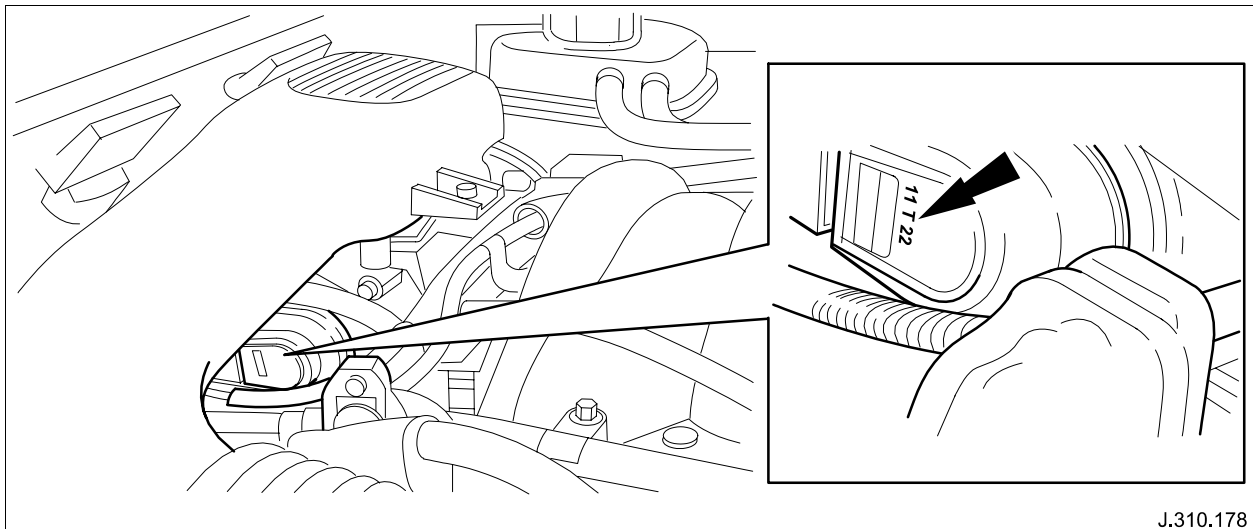
Illustration 2

3. Check date code of the throttle position sensor (Illustration 2).

Note: If the date code is within the range 10T5 to 11T25 inclusive, the throttle body must be replaced, proceed to step 4 of this workshop procedure. If the date code is not within the range 10T5 to 11T25 no further action is required. Proceed to step 34 of this workshop procedure.

If the date code is within the range 10T5 to 11T25, inclusive, replace the throttle body as described in the procedure on the next page.
