V8 XJ Series/XK

413-S484

TECHNICAL BULLETIN

Instrument Pack Assembly – CAN Failure – Service Action S484

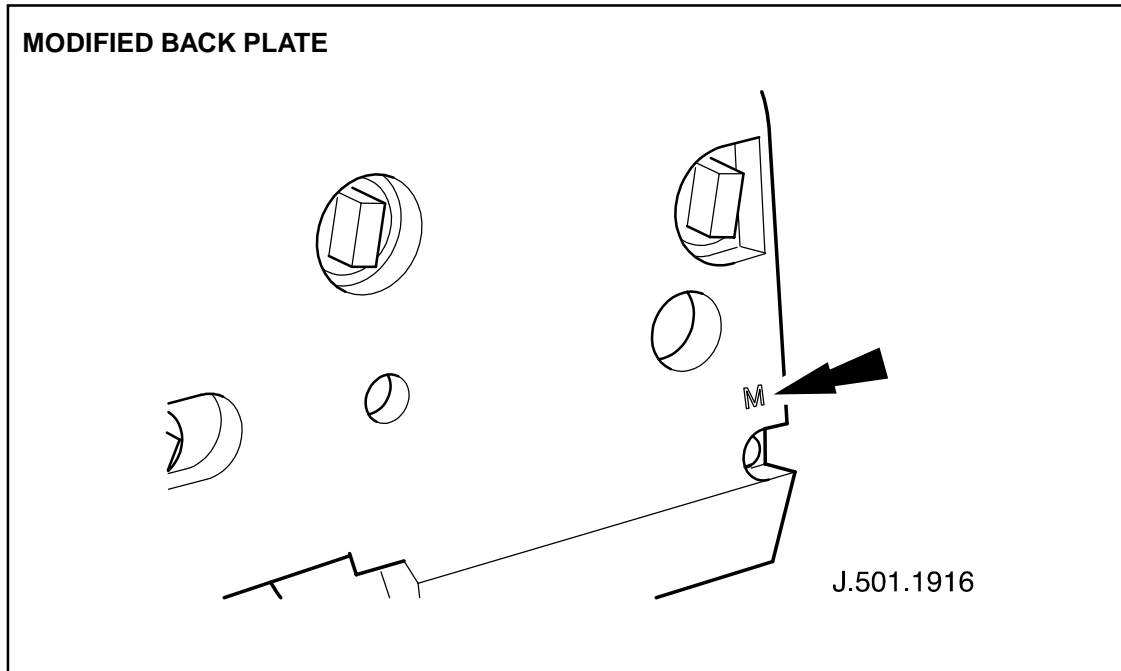
ILLUSTRATION 6

Note: The supplied modified back plate is identified by an “M” mark on the outer face, this will inform future workshops that the back plate has been replaced (Illustration 6).

14. Position and seat the new supplied module back plate. (Modified back plate has relieved screw boss).

15. Fit and tighten back plate securing screws. (Torque 0.5 - 0.8 Newton meters)
Suitable torque screwdriver for previous operation ‘Snap On’ QTSP135 or SPX 18 G.681 & T20 Torx bit.
