Front Suspension – Noise Diagnosis

MODEL 1997 MY-ON
XK8 Range

VIN
001001-ON

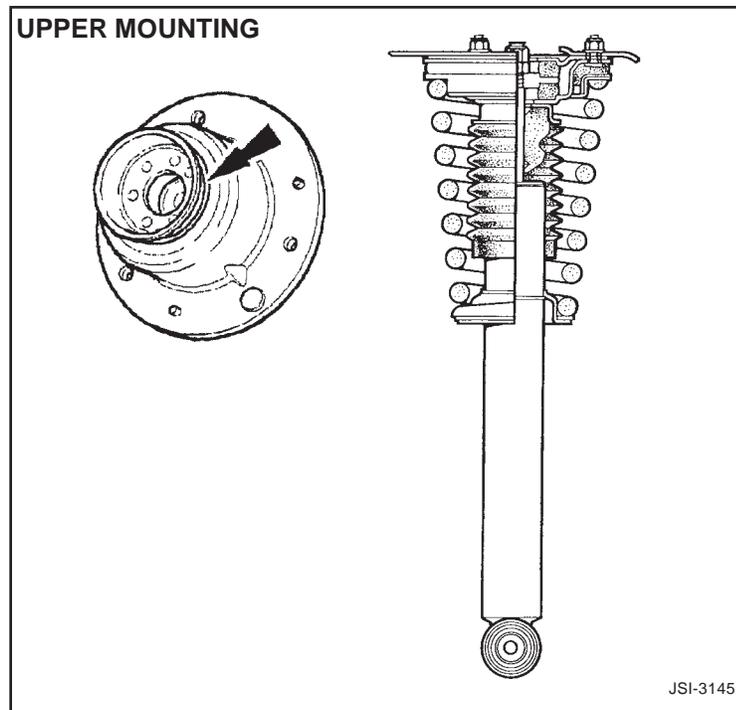
ILLUSTRATION 2

6. Using a pry-bar, carefully probe the area, indicated by arrows in Illustration 2, to check that the spring assister retaining cup has not become detached from the upper mounting. Isolated examples of this were found on vehicles prior to VIN 010565. A detached retaining cup will not affect the suspension other than causing a noise.
