**Intermittent Illumination of Instruments/False
Warning Messages –
Harness Connector Latch**

MODEL
1998 MY XK8 Range
1998 MY V8 XJ Series

VIN
029755-029891
849517-849885

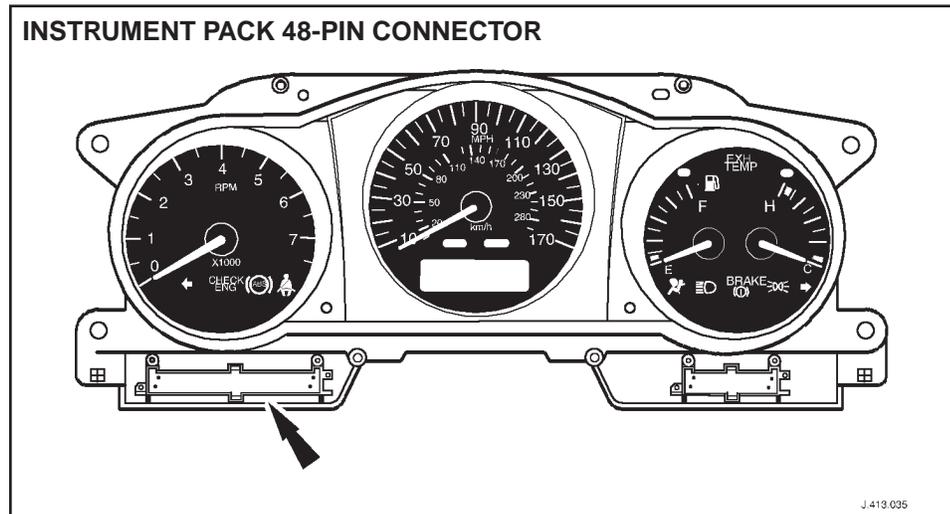
ILLUSTRATION 1

Some 1998 MY XK8 and V8 XJ Series vehicles within the above VIN ranges may experience intermittent illumination of the instruments and/or erroneous warning messages. The fault may be caused by a defective retaining latch in the Instrument Pack harness connector (arrowed, Illustration 1).

1. On V8 XJ Series vehicles, remove the veneer finisher. On XK8 vehicles, lower the underscuttle.
2. On all vehicles, gently move the harness wires at a position near the connector. If the connector has not latched into position correctly, some movement of the connector in the Instrument Pack will be noticeable.

3. With the ignition switched on, move the harness to check for the erratic illumination of the Instrument Pack.

4. If the connector cannot be latched securely, replace the instrument pack. Contact the Zone Parts Department to order an instrument pack.
