V8 XJ Series/XK

413-S484

### Instrument Pack Assembly – CAN Failure – Service Action S484

MODEL  
2000 MY XK Range  
2000 MY V8 XJ Series  
VIN  
A00116-A05322  
F00103-F09691

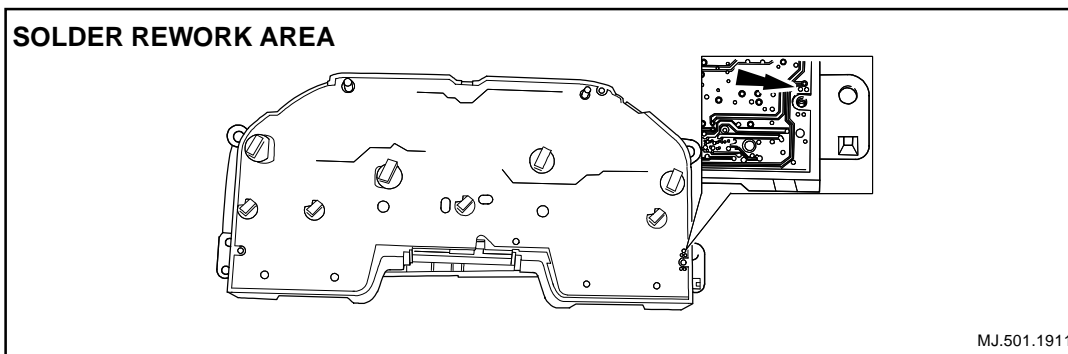
ILLUSTRATION 1

6. Place instrument pack on mat face down - use care not to damage the lens.
7. Undo and remove module back plate securing screws. (Torx T20)
8. Displace back plate using hinge action on paper adhesive label and place aside - careful not to rip the label.
9. Carefully remove back plate from the paper adhesive label and place aside - do not rip the label.
10. Examine circuit board to determine if rework to solder area is required. (Refer to Illustrations 1 - 4).

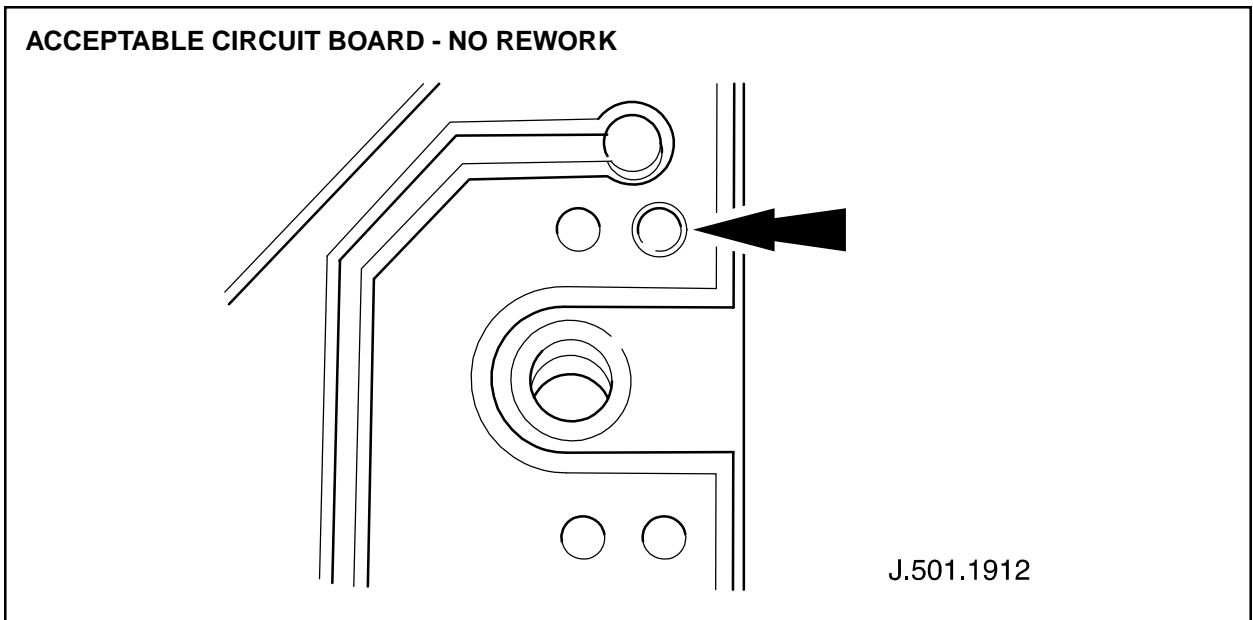
ILLUSTRATION 2

Illustration 2 shows an acceptable circuit board. This board does not require rework.

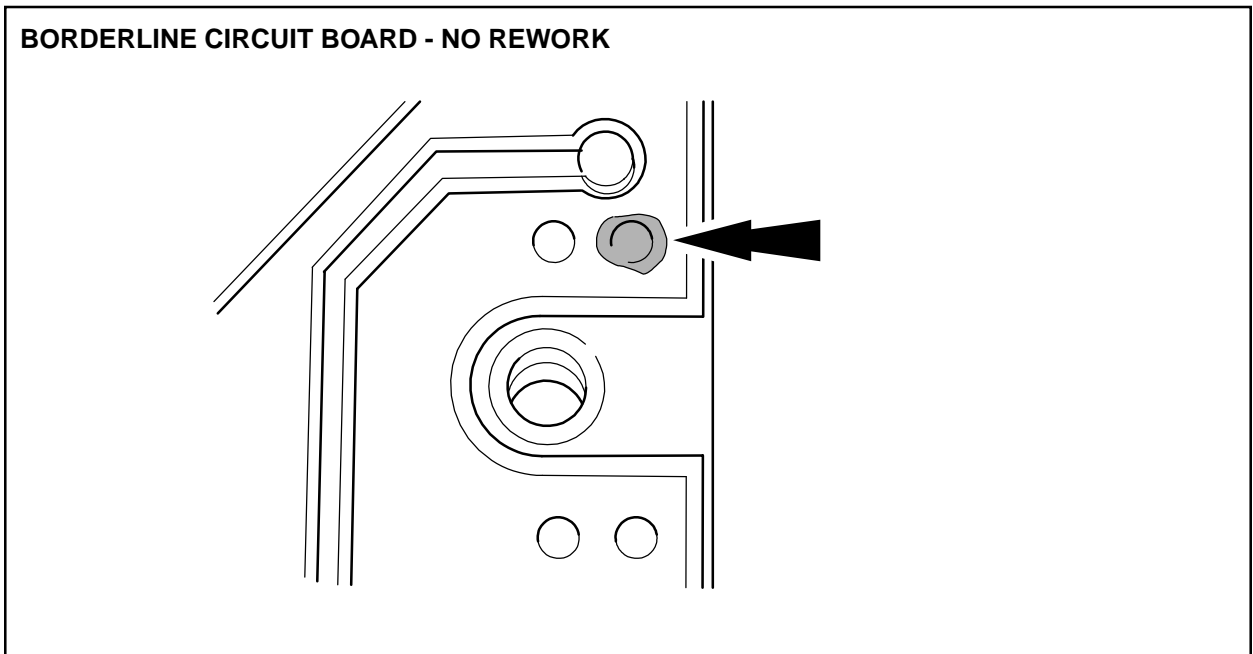
ILLUSTRATION 3

Illustration 3 shows a borderline case. This circuit board does not require rework.

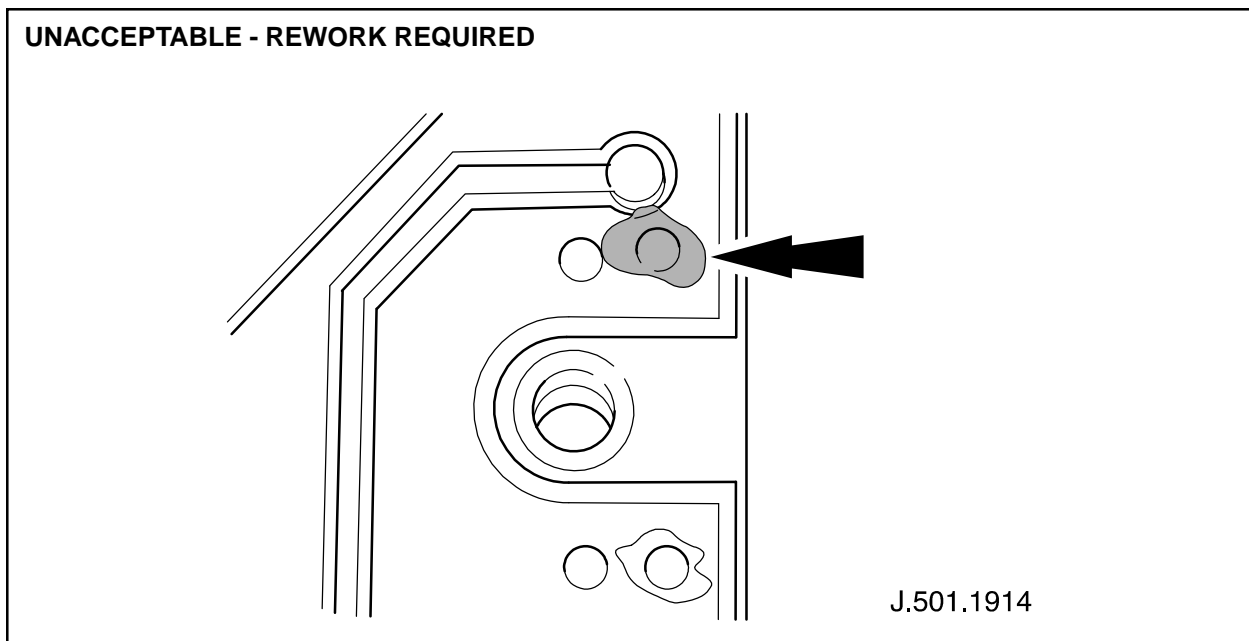
ILLUSTRATION 4

The cause of this has been identified as a Controller Area Network (CAN) failure in the instrument pack caused by a short to ground. This is due to a combination of pressure from the instrument pack back plate and possible migration of solder on certain printed circuit board contacts.

Illustration 4 shows an unacceptable case. This circuit board requires rework

**If rework of the solder area is required (Illustration 4) proceed to step 11.**
