Your Vehicle: 1999 Jaguar XK-8 Convertible (X100) V8-4.0L (AJ27)

Window - Rear Quarter Window Failure

501-49

Rear [Quarter Window Regulator](#) Failure - Excessive Bracket Flex - Repair Procedure

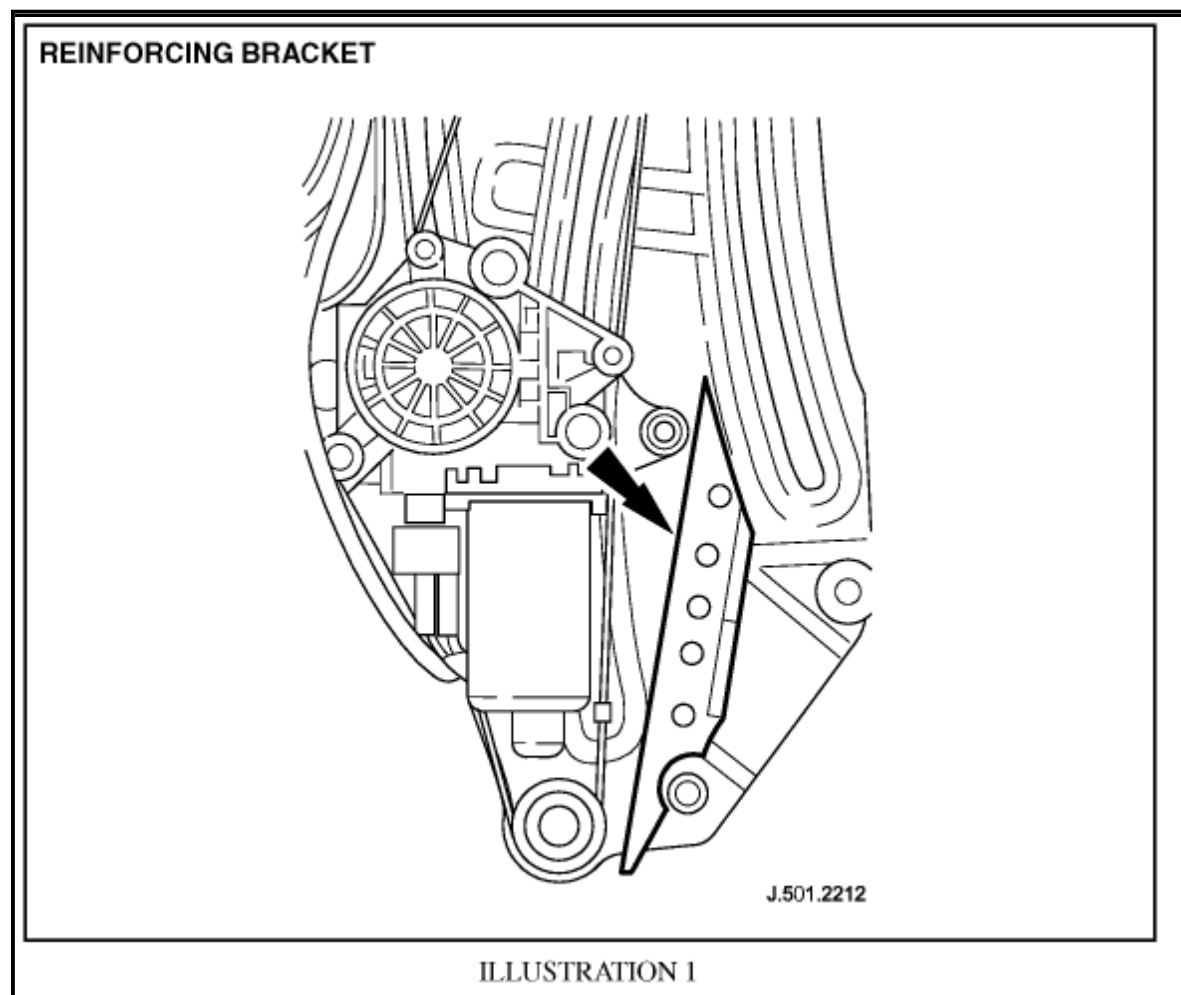
Some 1999-2000 MY XK convertibles, within the above VIN ranges, may experience customer complaints of failure of the regulator for the rear quarter window. It has been identified that the rear [quarter window regulator](#) assembly base plate may be made from a softer than normal metal. Although this material is within specification, it can lead to excessive flexing of the base plate, subsequently leading to the drive cable becoming detached. To eliminate this concern, a reinforcing bracket has been added to the bottom of the assembly to improve stability.

Note: If only one side rear [quarter window regulator](#) has failed, inspect the opposite regulator to see if it is equipped with a reinforcing bracket (Arrowed area in Illustration 1.) If not replace both regulators.

If a regulator fails, replace the assembly with the latest level regulator. The opposite side must also be checked for the latest level component and replaced if necessary.

3. Install new rear [quarter window regulator](#)(s) (see Workshop Manual, JTIS CD ROM, section: 501-11, SRO 86.25.11).
