In an effort to aid in the infamous P0171 and P0174 codes that lead to a lean running condition, I have color coded all vacuum lines.

I believe that the following pictures will go from MY (**Model Year**) 2003 on up. There seems to be some confusion with 2 vacuum elbows located **under** the lower intake manifold. I believe these 2 elbows are on MY 2002 and older, these are a known failure.

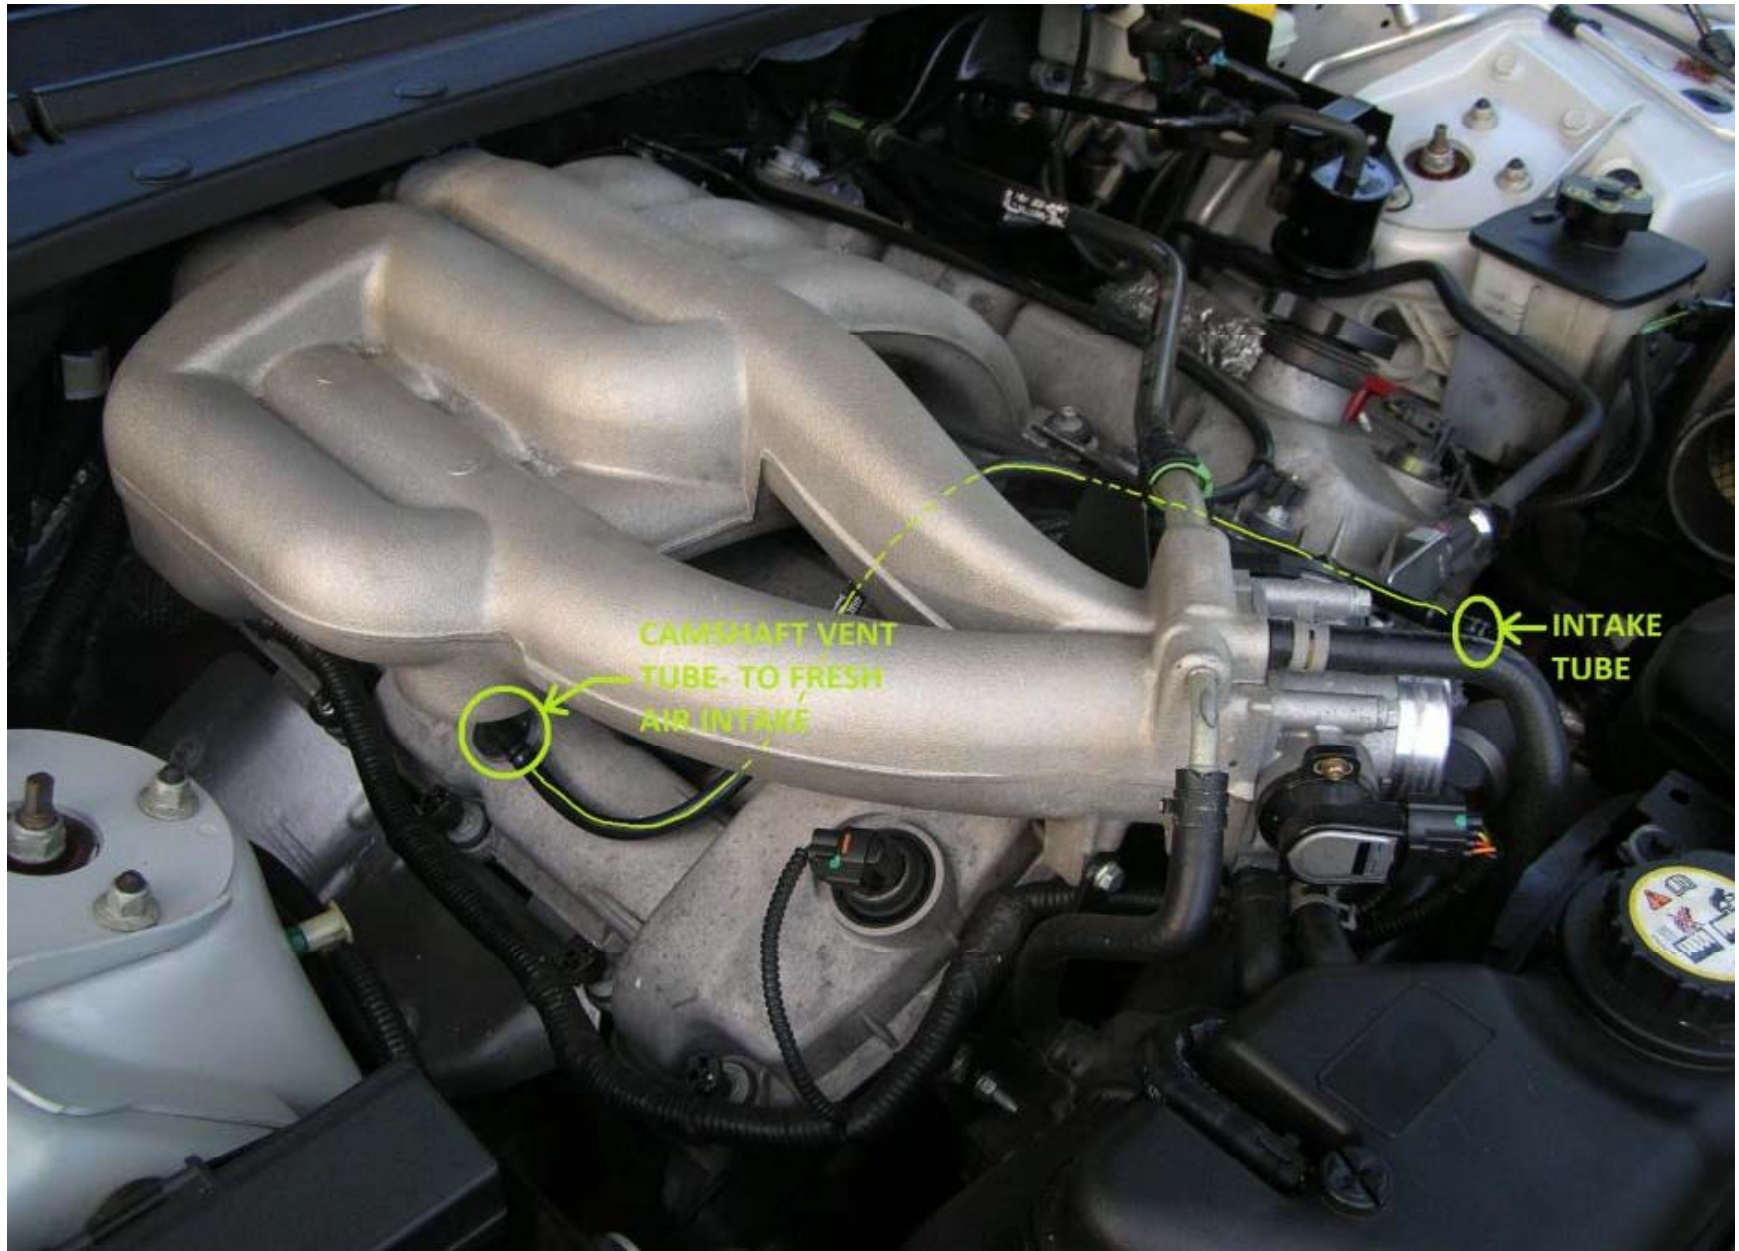
To check for vacuum leaks use either carb cleaner or water in a misting bottle. Remove the plastic engine cover to access all lines. Run [vehicle](#) and liberally spray down vacuum lines one at a time, if the engine revs up, time for further inspection. Included as well are MAF Sensor location and IMT O-Rings. The above is the first place to start in hunting down the P0171 and P0174 codes.

In above picture, the Fuel Pressure Regulator Vacuum Line is just a short 90 degree elbow. No visible picture able to be taken.

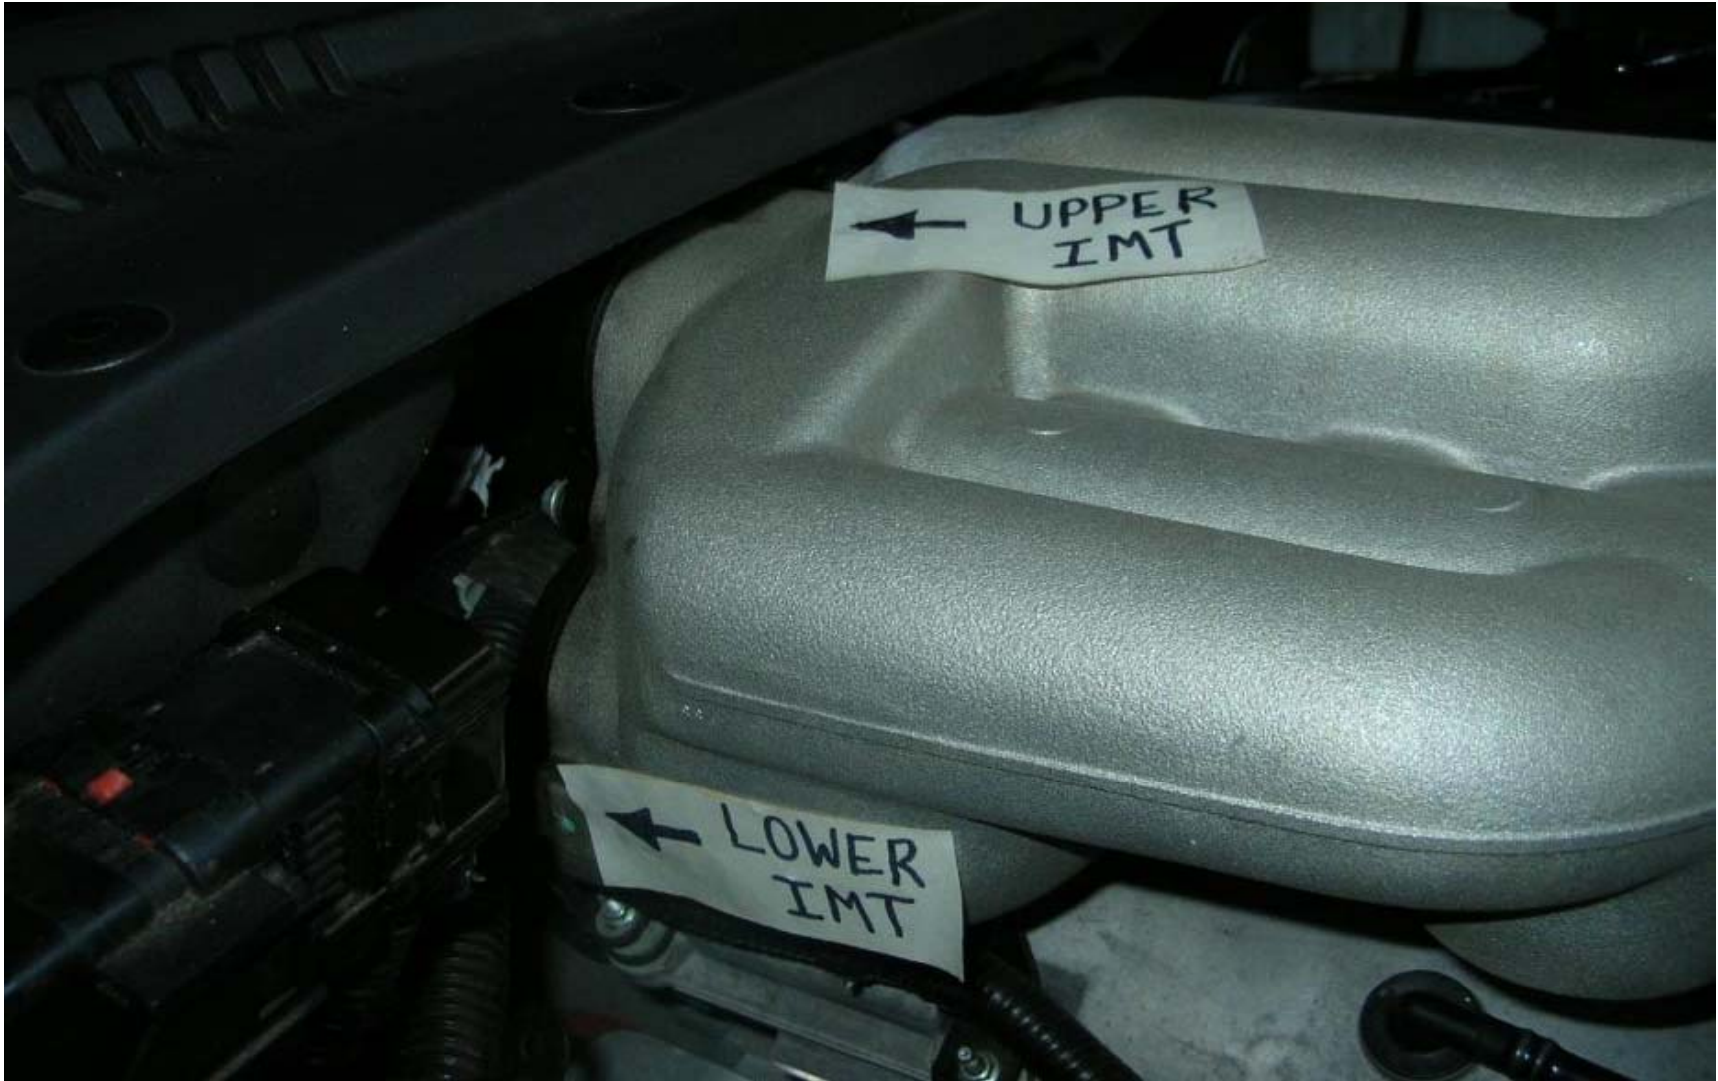
Here is a simple check of the IMT O-Rings on a 2005 3.0. Note different years have different locations.

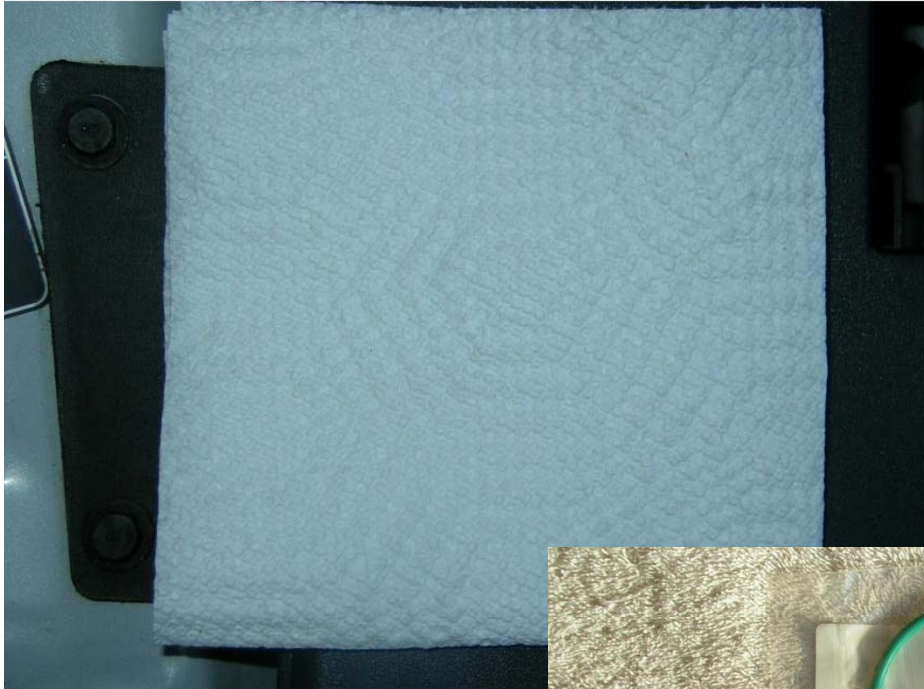
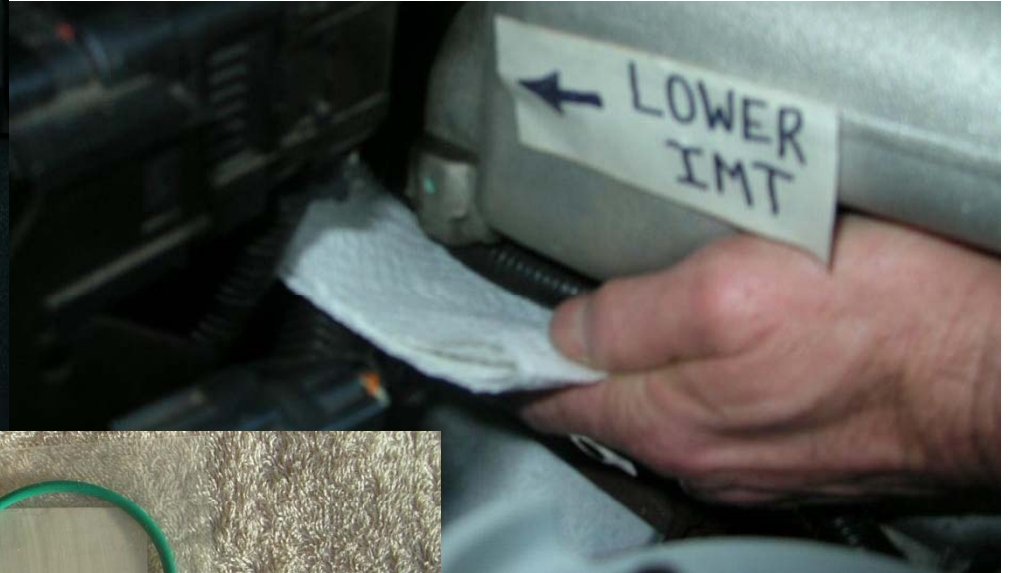
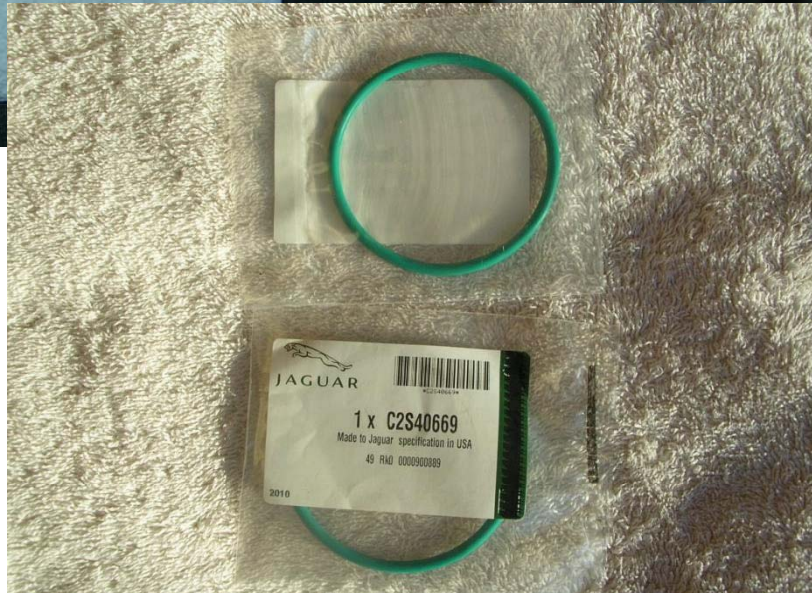
1) Simply fold a clean paper towel in quarter

2) Wipe the lower portions of the IMTs (tuning valve), if oil is present on paper towel, your IMT O-Rings need to be replaced.
