**Squeaks & Rattles – Noise from Bulkhead  
Brake Line – Install Isolating Pads & Clip****MODEL** 1995 MY  
Sedan Range  
**VIN**  
720001 - 736560**ISSUE:**

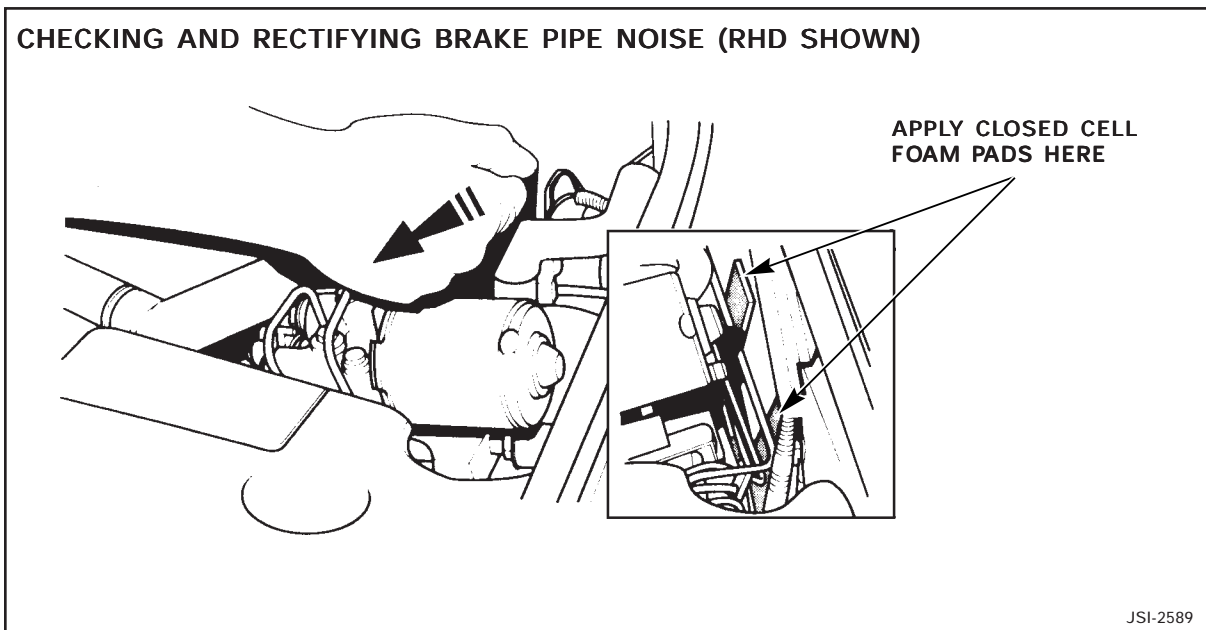
ILLUSTRATION 1

Some 1995 MY Sedan Range vehicles, within the above VIN range, may experience a noise that the customer reports as coming from the right side of the fascia. The source of the noise may actually be in the engine compartment and be caused by contact between a brake line and the bulkhead or between two adjacent brake lines.

If a customer reports a noise from the right side fascia on a 1995 MY Sedan Range vehicle within the above VIN range, check if the noise described by the customer can be reproduced by gently striking the ABS hydraulic unit with the hand as shown in Illustration 1.

1. Clean the surface of the bulkhead and apply two closed cell foam pads (part no. HNA 1210BA) to the locations shown in Illustration 1, to prevent direct contact between the pipes and the bulkhead.
