This illustration is provided by Rick @ www.jaguarforums.com

In an effort to aid in the infamous P0171 and P0174 codes that lead to a lean running condition, I have color coded all vacuum lines.

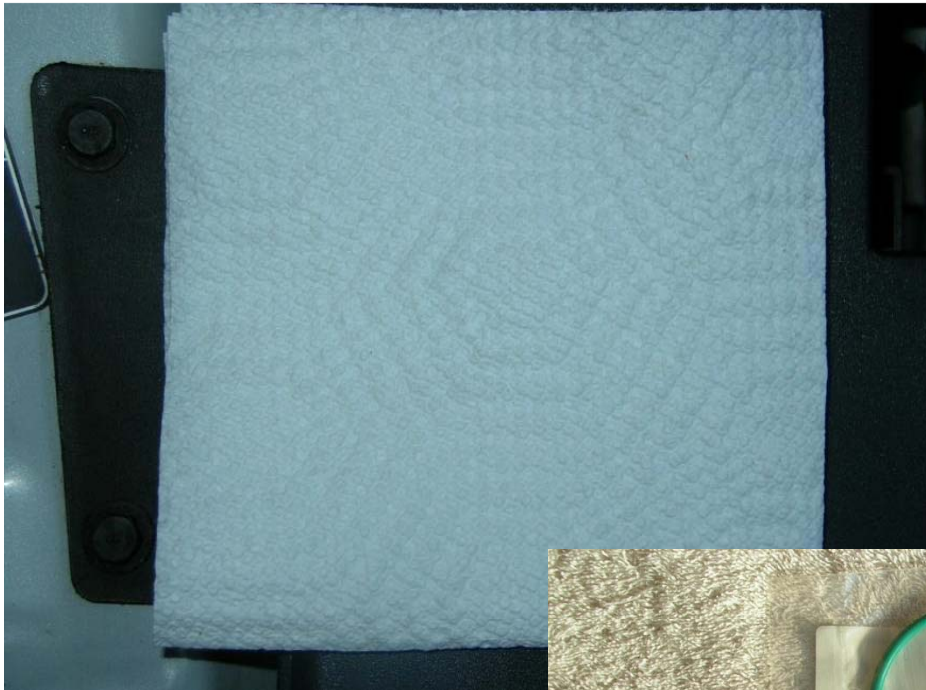
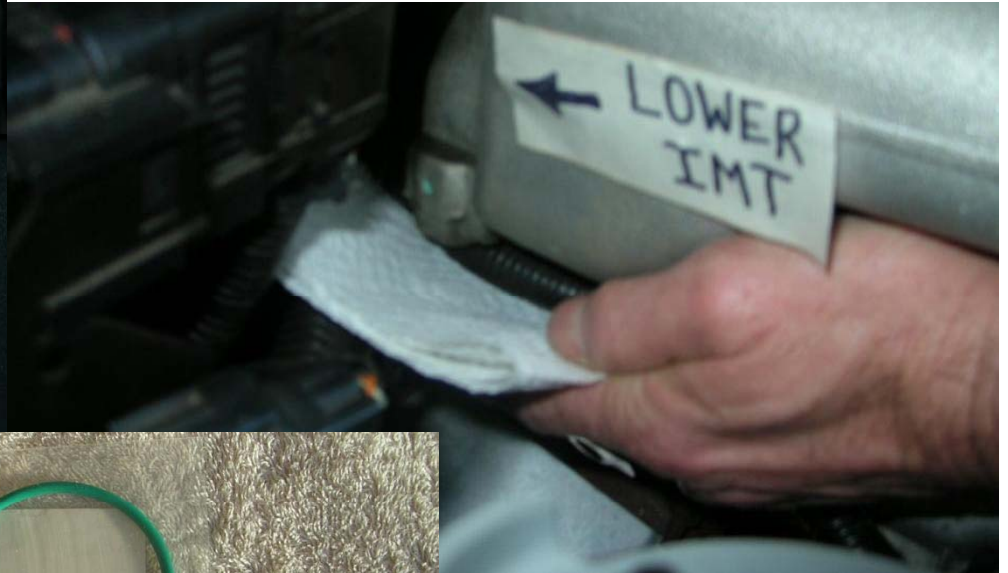
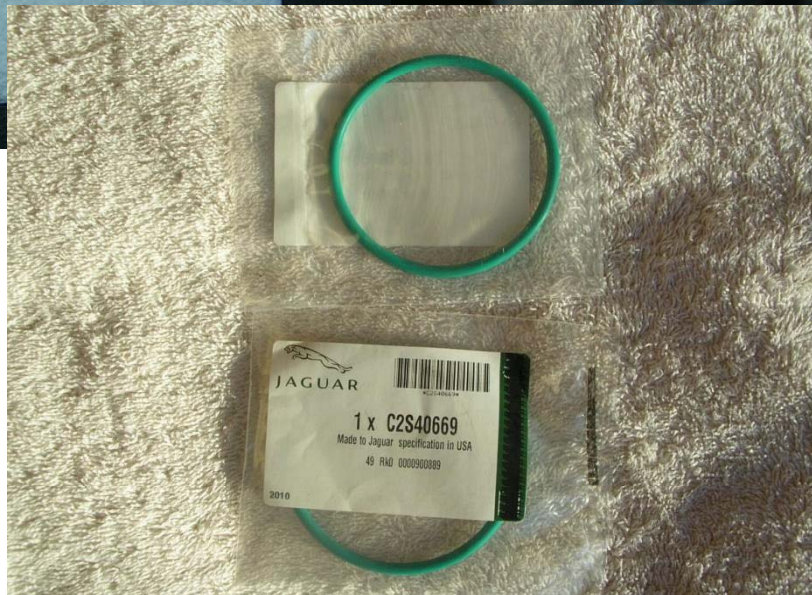
1) Simply fold a clean paper towel in quarter

2) Wipe the lower portions of the IMTs (tuning valve), if oil is present on paper towel, your IMT O-Rings need to be replaced.
