© D. Jensen 2006	<b>REPLACEMENT OF TRANSMISSION EXTENSION-CASE GASKET AND OUTPUT-SHAFT SEAL ON '95 XJ6</b>	V. 1.0 June 2006
Distribution: www.jag-lovers.com

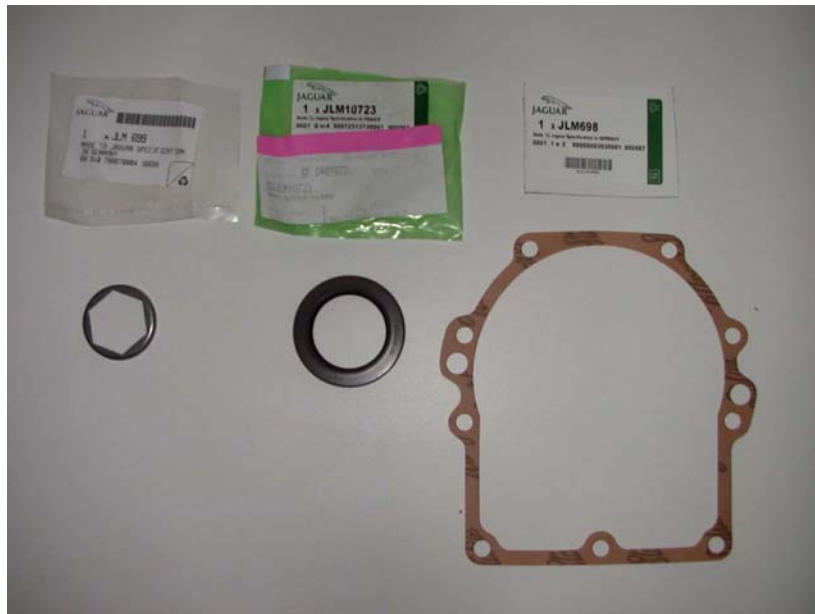
Fig. 1 Replacement parts

1. Purchase the required replacement parts: JLM 699, tab washer, \$2.90; JLM 10723, output-flange seal, \$19.87; and JLM 698, extension-case gasket, \$3.25 (see Fig. 1).

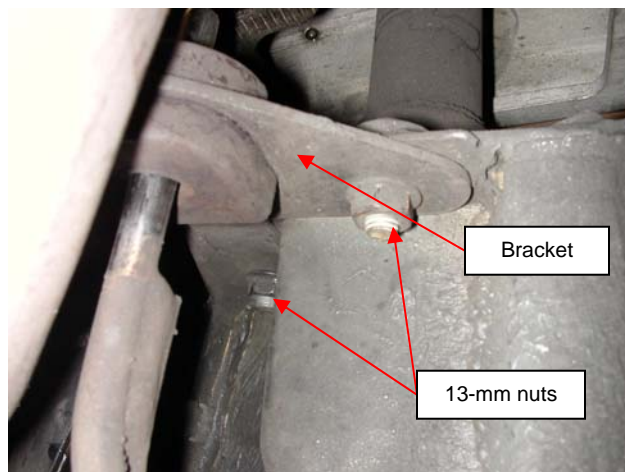
Fig. 2 Tail pipe support bracket (left side)

3. Drain transmission. I'm not sure this step was necessary, but it was easy to do and avoided any potential leakage of fluid that might be above the level of the extension-case lower lip.
4. Remove Rear Catalyst
  - a. Remove rear-muffler supports from both hangers using a 13-mm open-end wrench (see Fig. 2). Removing the brackets allowed more twisting and turning of the rear-catalyst outlet pipes during their removal, which was needed since the pipes had not been removed since the car was manufactured.

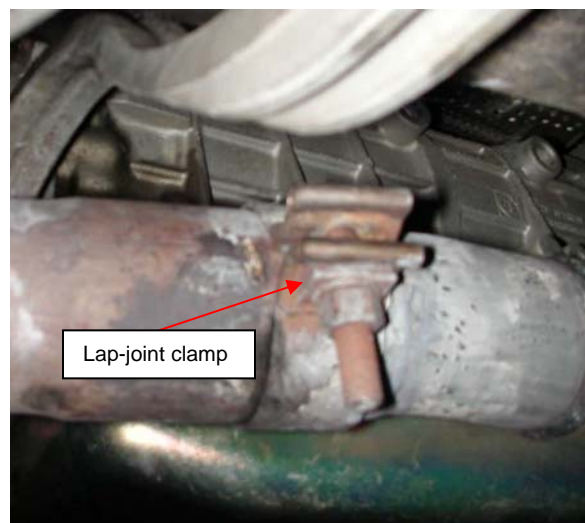
Fig. 3 Clamp between front and rear catalyysts

Loosen the lap-joint exhaust clamp (e.g., Torca TorcTite) securing the rear-catalyst inlet pipe to the front-catalysts down pipe using a 15-mm wrench (see Fig. 3).

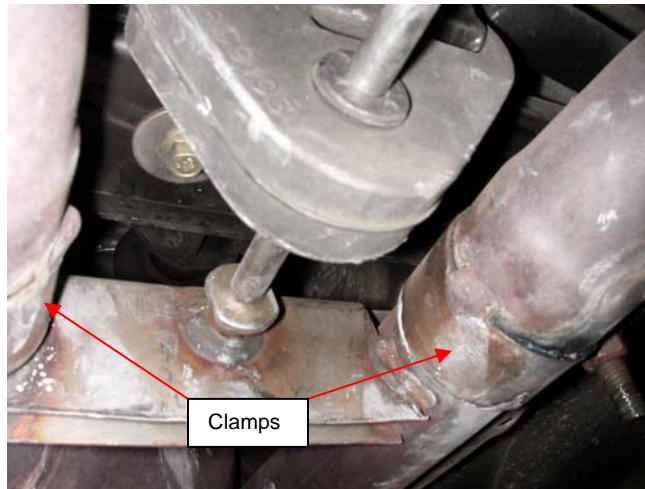
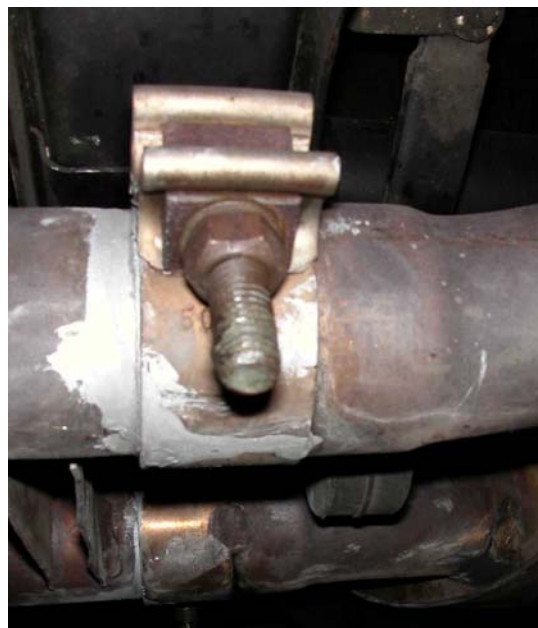
- b. Loosen both clamps securing the catalyst outlet pipes to the front mufflers using a 15-mm wrench (see Figs. 4 and 5). [Note: several of the photos were taken after the job was complete. The abundant use of anti-seize lubricant is thus evident on most fittings.]

Fig. 4 Upward view of rear-catalyst outlet pipes and clamps

Fig. 5 Side view of rear-catalyst outlet pipes and clamps

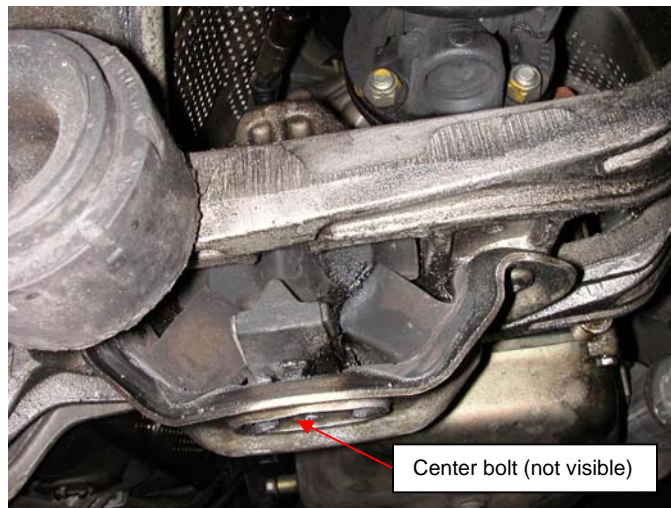
Fig. 6 Transmission support bracket

5. Remove the transmission support bracket and shift/electrical cables
  - a. Locate the floor jack under the transmission bell housing and lift the transmission and motor slightly to take the weight off of the support bracket and transmission mount.
  - b. Photograph and mark the location of the transmission support bracket as it attaches to the frame. This is necessary to ensure that the bracket does not contact the transmission housing during reinstallation, leading to very loud gear and engine noises and elevated blood pressure (guess how I found out). Remove the four star-headed (Torx) bolts securing the mounting bracket to the body using a T40 driver. The bracket will then be free to swing about from the center bolt holding it to the transmission mount (see Fig. 6).

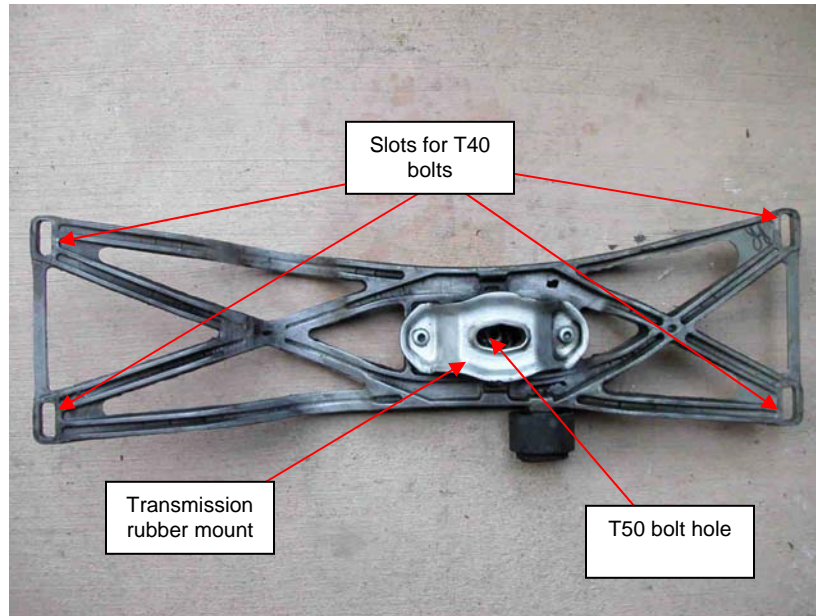
Fig. 7 Bottom view of transmission support bracket

- c. Remove the transmission bracket and rubber mount as a unit by removing the bolt in the center of the bracket/mount using a T50 driver. Place the bracket/mount aside (see Fig. 7)

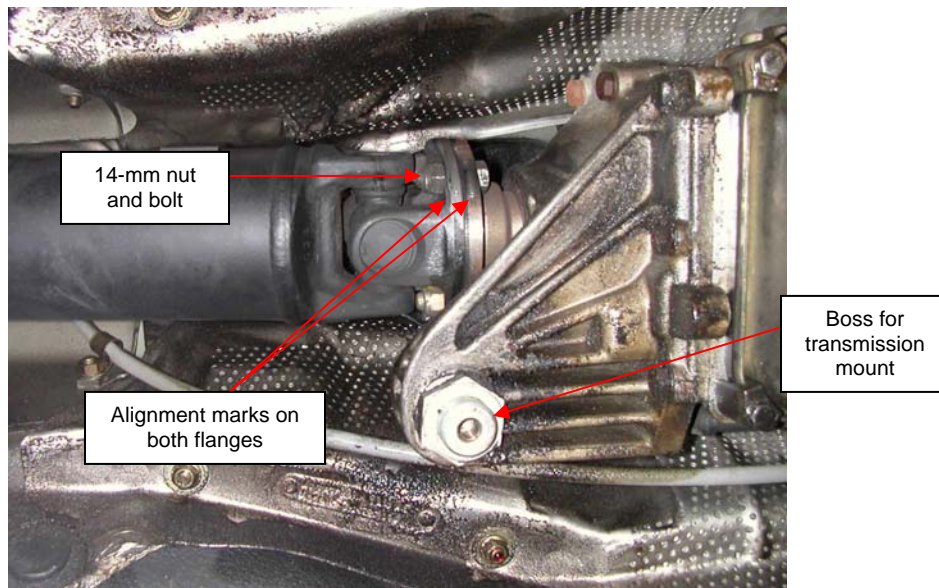
Fig. 8 Connection of prop-shaft flange to output flange

6. Disconnect the prop shaft
  - a. Mark the radial location of the transmission output-shaft flange and the prop-shaft flange using a center punch (see Fig. 8).

- b. Remove the four 14-mm nuts and bolts securing the prop shaft to the output flange and allow the prop shaft to rest at its low point. All four of the bolts on my car were loose, allowing for some free play between the two flanges.

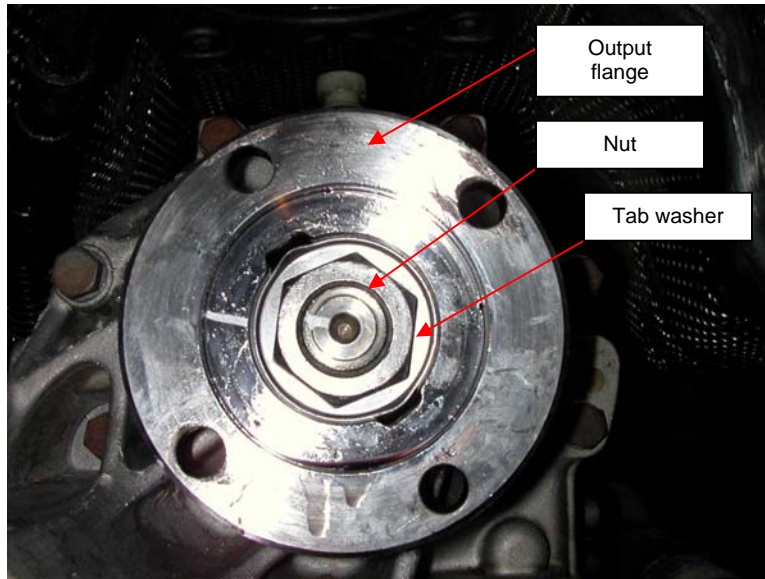
Fig. 9 Output flange nut and tab washer

- a. Pry the tab washer, used to lock the output-flange nut, from the flange using a screwdriver (see Fig. 9).

- a. As the Jag manuals say, "Assembly is the reverse of removal". In this case, it's true. Note that when the output-shaft-nut tab washer is pressed into place over the nut, it naturally "buckles" to fit into the slots in the output flange. No special bending or tapping is required.
- b. I could not find the recommended torque for the output-housing bolts so I torqued to ~30 ft-lb.
- c. As noted earlier, I used lots of anti-seize lubricant on the exhaust flanges, nuts and bolts to ease their removal at a later date if required.

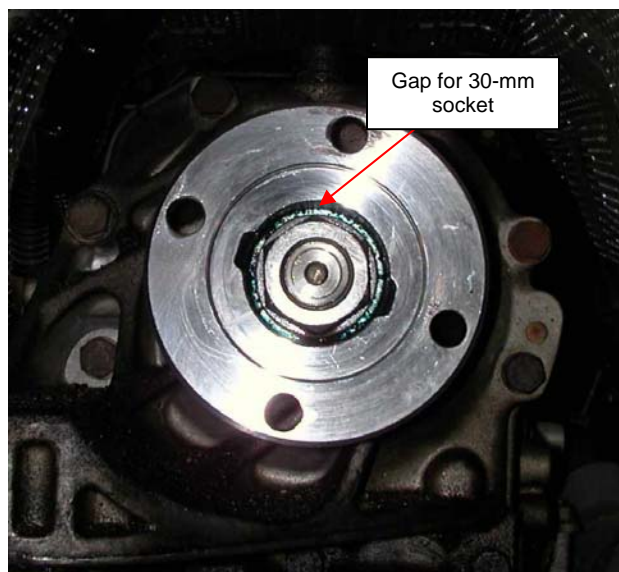
Fig. 10 Output flange with tab washer removed

- b. Place a normal 30-mm socket on the nut (I think the walls of an impact socket may be too thick to fit in the gap between the nut and flange i.d. wall, but I did not verify this) (see Fig. 10) and position a bolt slipped through one of the flange bolt

holes to keep the flange from rotating. Remove the retaining nut. The nut on my car was not much more than finger tight.

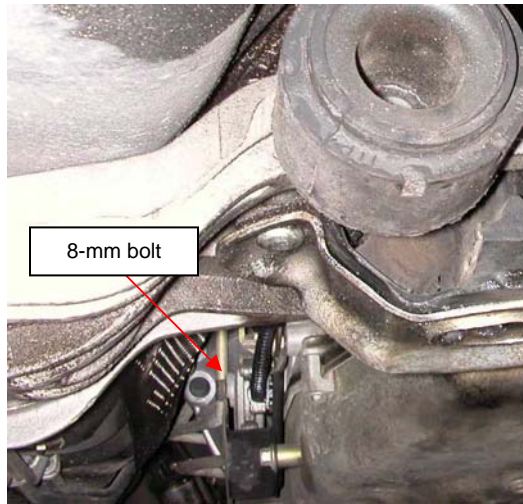
Fig. 11 Location of shifter cable and electrical connections

- c. Pull the flange from the transmission output shaft. Mine came off very easily by hand.
8. Remove the extension case
    - a. Remove the 8-mm bolt securing the transmission shift and electrical cables to the extension case after noting the location of the two cables (see Fig. 11).

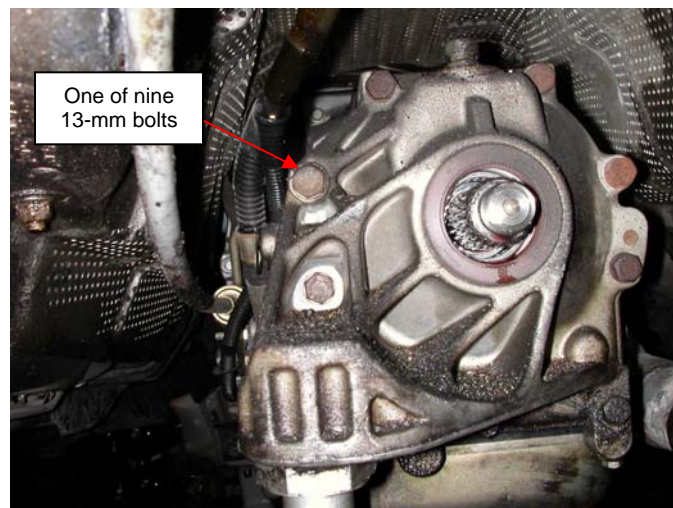
Fig. 12 Bolts holding extension case to transmission housing

- b. Remove the nine 13-mm bolts holding the extension case to the transmission housing (see Fig. 12).

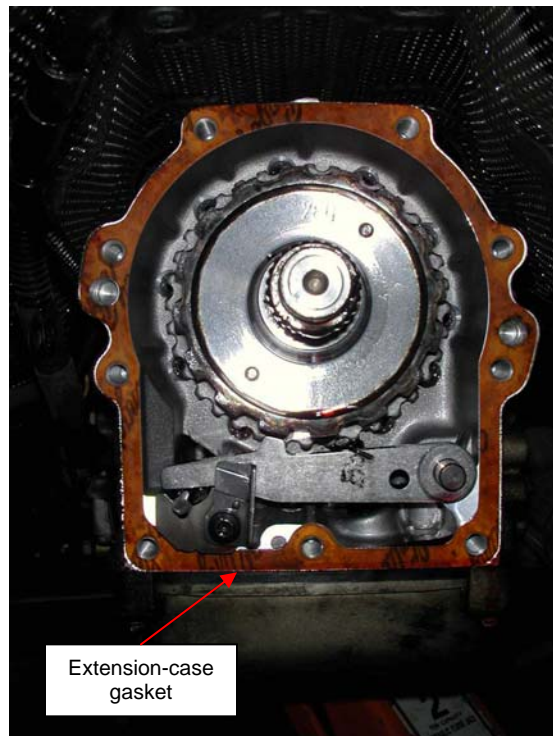
Fig. 13 Extension case gasket

9. Replace output shaft seal
  - a. Remove the old gasket material from the transmission and output housing. Mine came off easily with a painter's putty knife (Fig. 13). No gasket sealer was used.

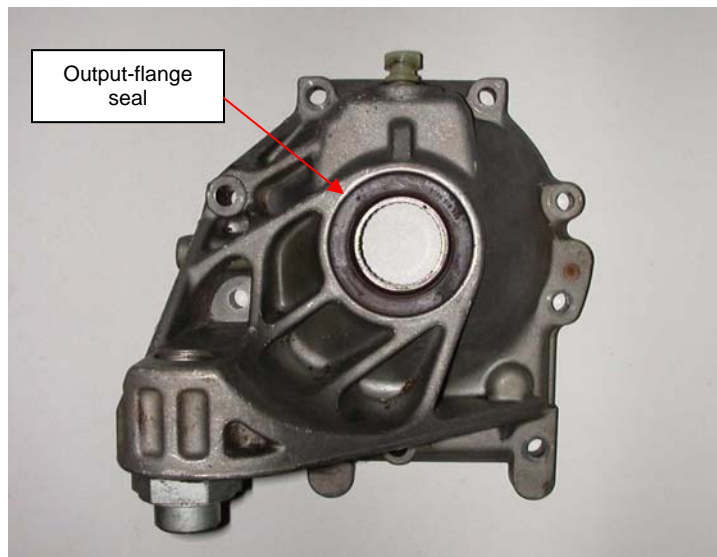
Fig. 14 External view of extension case showing flange seal

- b. Pry the old seal out (see Fig. 14) using a screwdriver or small pry bar. Tap new one in place using an appropriately sized socket.

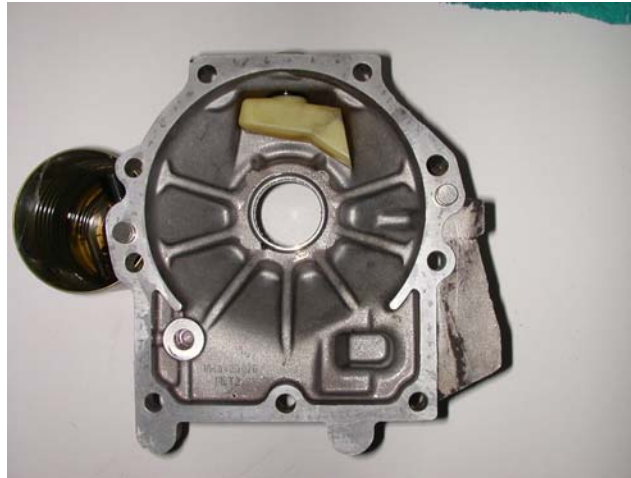
Fig. 15 Internal view of extension case

Figure 15 shows the inner view of the extension case.
