Inability to Shift Gears –
Selector Lever Moves Freely Through J-Gate
– Repair Procedure

MODEL 2003-05 MY
S-TYPE

VIN M45255-N52047

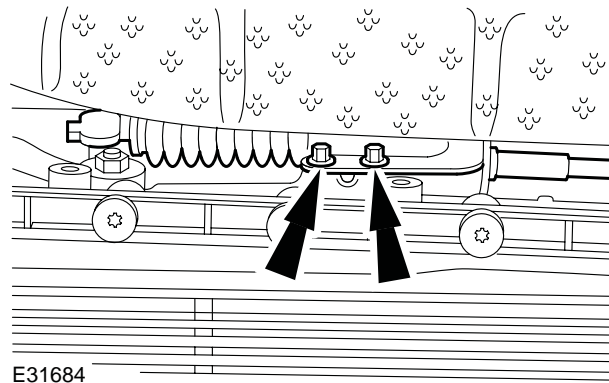
ILLUSTRATION 1

1. Raise vehicle on lift.
2. Remove the selector cable bracket retaining bolts (Illustration 1).

SELECTOR CABLE BRACKET RETAINING BOLTS

3. Clean retaining bolts threads and apply Loctite 243.

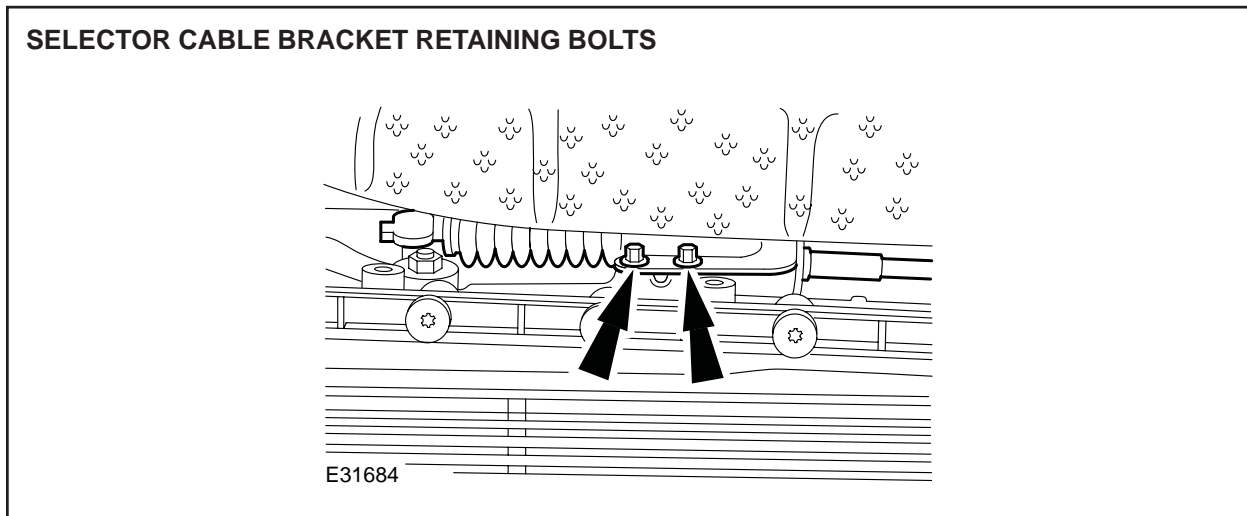
ILLUSTRATION 2

4. Install and tighten the selector cable bracket retaining bolts to 8 Nm (Illustration 2).

Note: Ensure the selector lever position corresponds to the illuminated gear indication light on the J-Gate. Any faults other than the selector cable bracket retaining bolts - Service fix, are to be carried out as a separate Warranty Claim.
