Squeaks & Rattles – Noise from Bulkhead  
Brake Line – Install Isolating Pads & Clip

MODEL 1995 MY  
Sedan Range  
VIN  
720001 - 736560

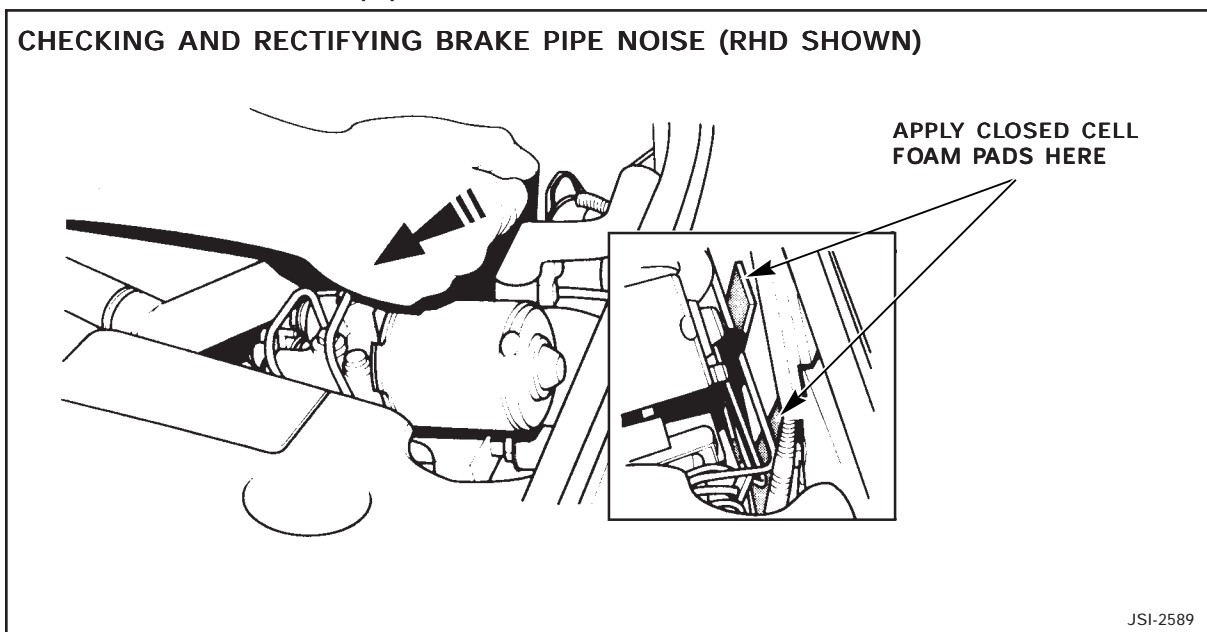
ILLUSTRATION 1

Some 1995 MY Sedan Range vehicles, within the above VIN range, may experience a noise that the customer reports as coming from the right side of the fascia. The source of the noise may actually be in the engine compartment and be caused by contact between a brake line and the bulkhead or between two adjacent brake lines.

If a customer reports a noise from the right side fascia on a 1995 MY Sedan Range vehicle within the above VIN range, check if the noise described by the customer can be reproduced by gently striking the ABS hydraulic unit with the hand as shown in Illustration 1.

1. Clean the surface of the bulkhead and apply two closed cell foam pads (part no. HNA 1210BA) to the locations shown in Illustration 1, to prevent direct contact between the pipes and the bulkhead.
