© D. Jensen 2005	<b>REPAIR OF RADIO ANTENNA ON '01 XK8 AND XJ6/XJ8s USING SIMILAR HARADA ANTENNAS*</b>	V. 1.0 Dec. 5, 2005
Distribution: www.jag-lovers.com CC: X300/XK8 List Administrators

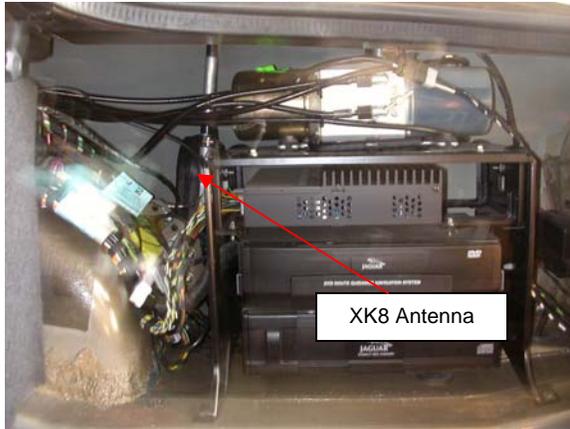
Fig. 3a XK8

3. Both: locate the antenna. In my case, the XK8 antenna is positioned behind the CD changer, navigation-system DVD, audio amplifier, and convertible-top hydraulic lines (Fig. 3a). It is far easier to access the antenna in the XJ6 and removal is self evident (Fig. 3b)

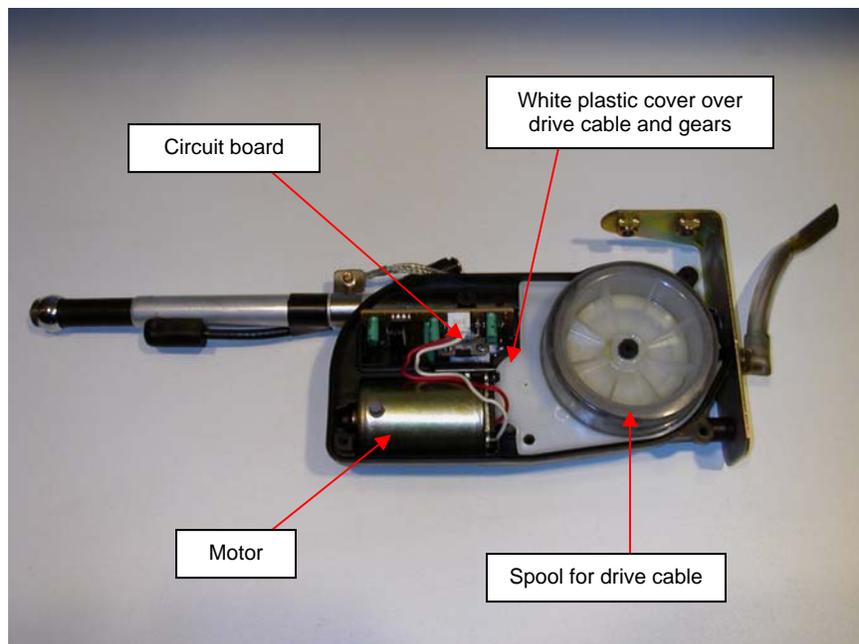
Fig. 6

6. The antenna comprises a motor, circuit board, gears and spool for the wand, and has a minimum of electrical connections (Fig. 6). Start and stop of the motor depends on changes in electrical properties, i.e., current draw, voltage spike

or some other electrical property (I am not a EE and don't understand the mechanism of control). Mechanical rocker switches found in lower-tech (i.e., lower-cost) aftermarket antennas are not used.

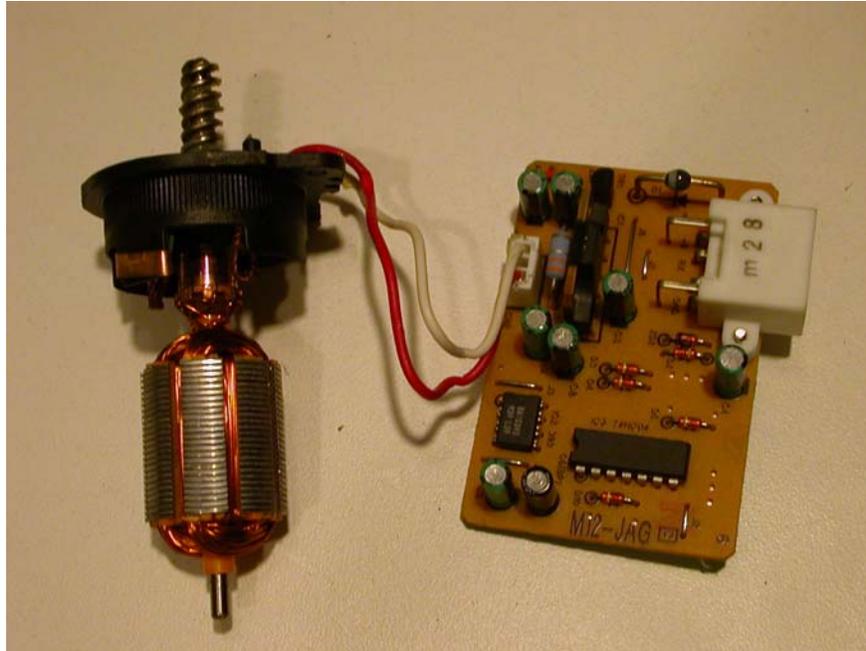
Fig. 9

9. Pull the armature and brush assembly from the motor housing (Fig. 9). A good pull is required due to the magnetic fields tending to hold the armature in place. There are no screws or other means of attachment. Note the number on the circuit board, "M12-JAG", perhaps indicating a Jaguar-specific design.
