TECHNICAL BULLETIN

Oil Cooler Feed Pipe/Hose Failure –
Inspect/Replace Hose –
Service Action S846

MODEL 2004-05 MY
XK Range

VIN A39699-A41740

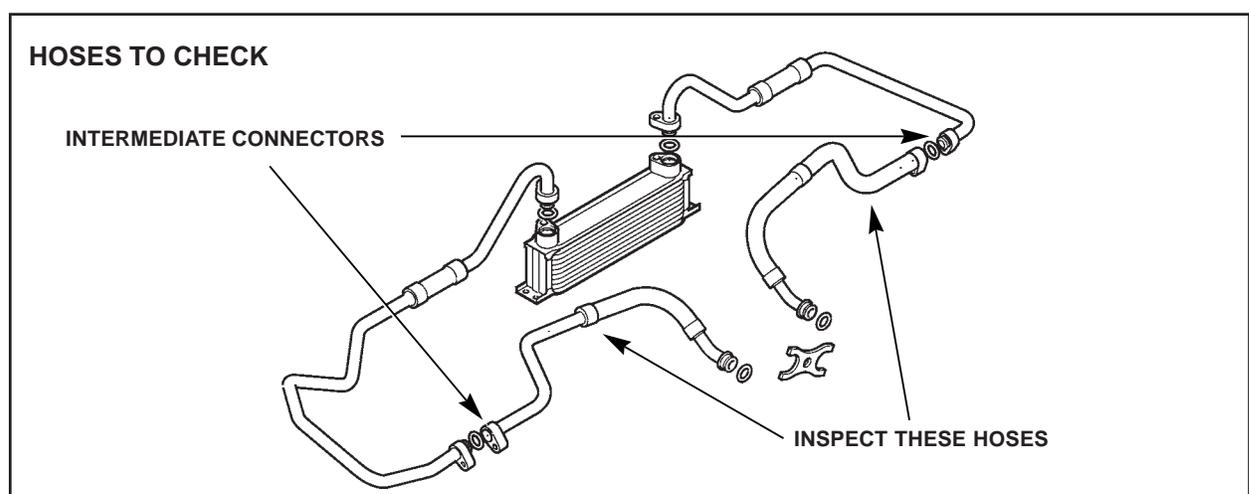
A concern has been identified on a number of 2004-05 MY XK Range vehicles within the above VIN range. A failure can occur at the outer crimp face of the oil cooler feed pipe/hose that leads from the engine to the intermediate connector. The same problem can occur on the oil cooler return pipe/hose leading from the intermediate joint back to the engine. These conditions can result in the possibility of engine oil loss and reduced engine performance.

Inspect, at the first available opportunity, all 2004-05 MY XK range vehicle within the above VIN range. Check the feed hose/pipe leading from the engine to the intermediate connector and the oil cooler return pipe/hose from the intermediate connector back to the engine for a date code of **43 03**.

If the date code is illegible, not present, or reads **43 03** on either the engine to intermediate connector oil cooler feed pipe/hose or the oil cooler return pipe/hose, both pipe/hoses must be replaced.
