# TECHNICAL BULLETIN

## Poor Idle Quality – Normally Aspirated AJ16 Engine – Valve Timing Modification

12-57

MODEL 4.0L Normally Aspirated 1995 MY DATE 8/95

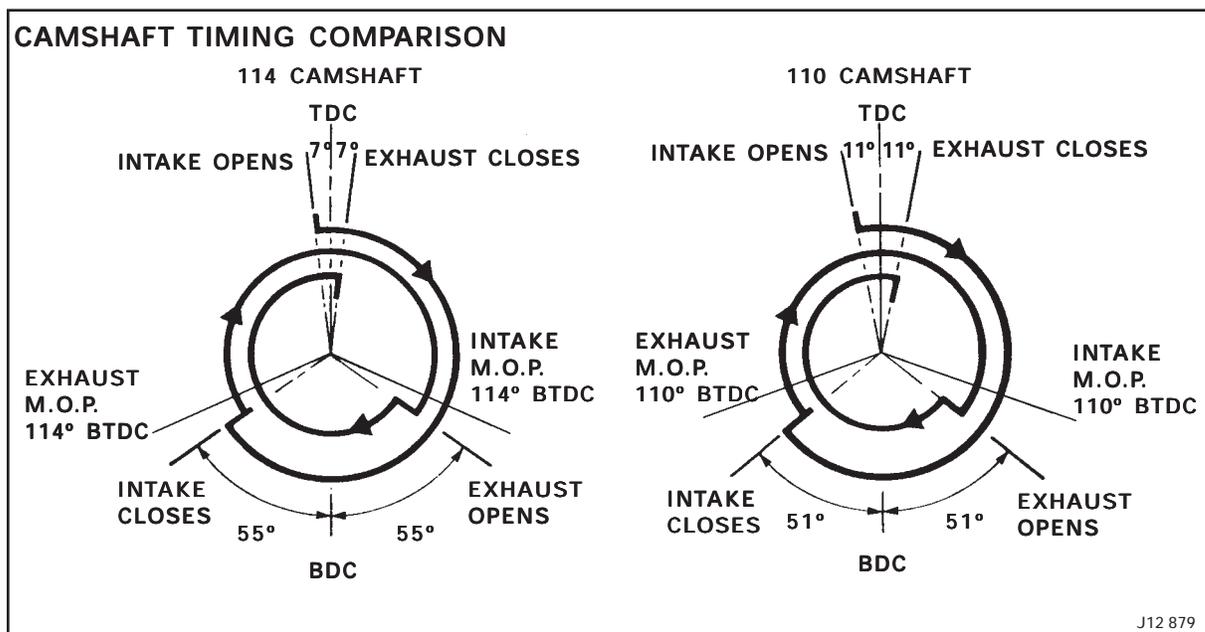
ILLUSTRATION 1

position. The valve timing overlap is reduced from 22 degrees on the 110 camshafts to 14 degrees on the 114 camshafts, Illustration 1.
