Sedan Range

08.2-01

TECHNICAL BULLETIN

Transmission MIL Illumination – Revised EPROM – Replacement Procedure

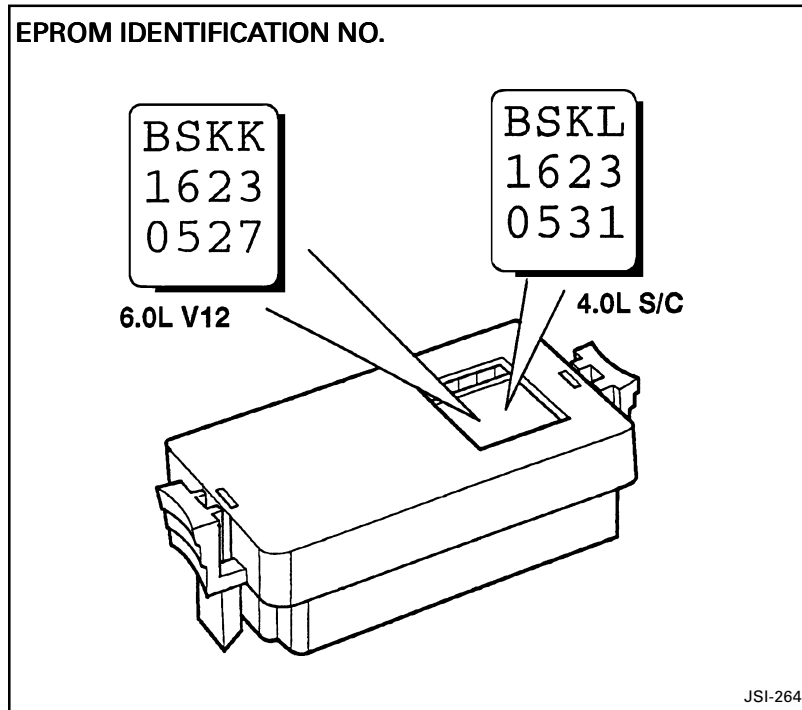
ILLUSTRATION 4

NOTE: The EPROMs for the 4.0L SC and the 6.0L V12 applications are **not** interchangeable.

Install the replacement EPROM module in the board socket while holding the board through the opening in the end support. Press the EPROM down into the socket until the latches engage.
