V8 XJ Series/XK8

303-35

TECHNICAL BULLETIN

Difficult Cold Start – Normally Aspirated Engines – ECM Flash Reprogramming – Service Action S479

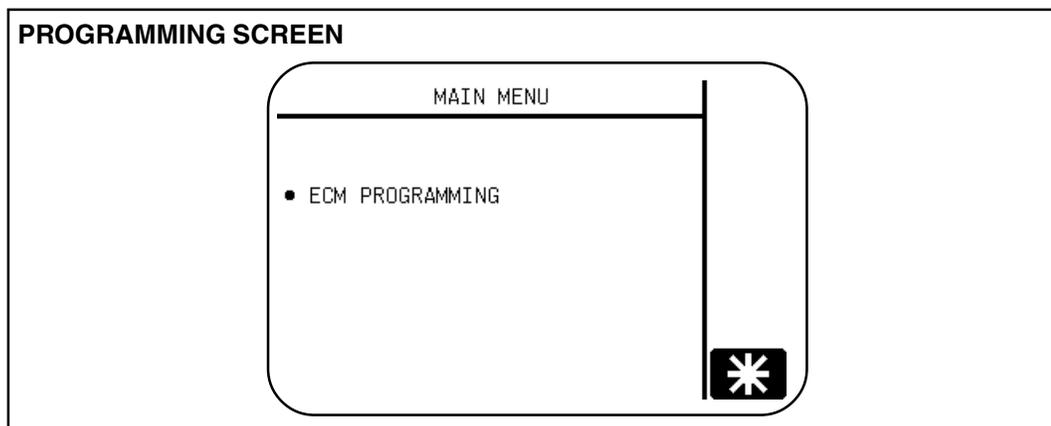
ILLUSTRATION 1

5. **On all vehicles**, connect the PDU to the base station and then insert the CD-ROM into the base station drive. Highlight **'ECM Programming'** and select the **check** icon (Illustration 1). (The Main Menu will appear with only one option, **'ECM Programming'**. Select this option and the **check** icon to continue.

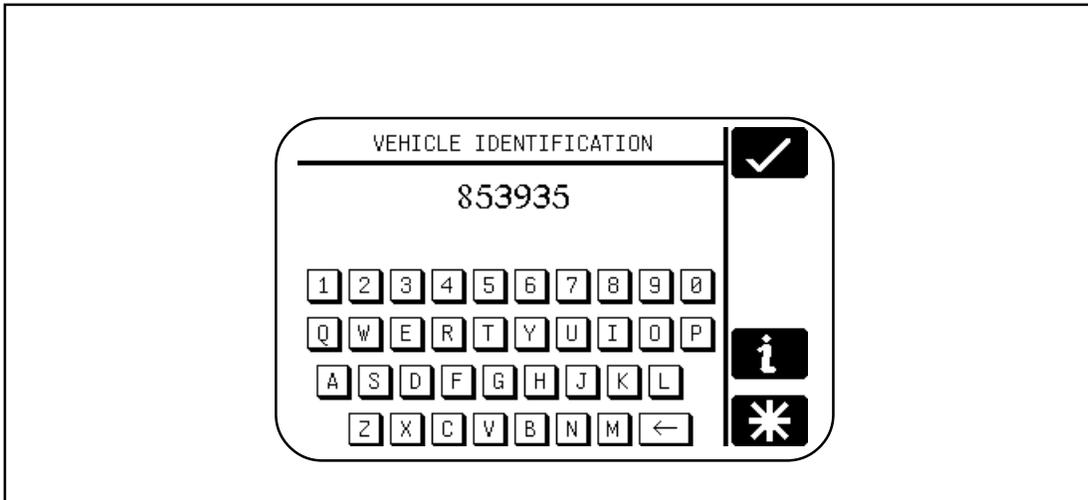
ILLUSTRATION 2

6. Enter the VIN and other vehicle information.

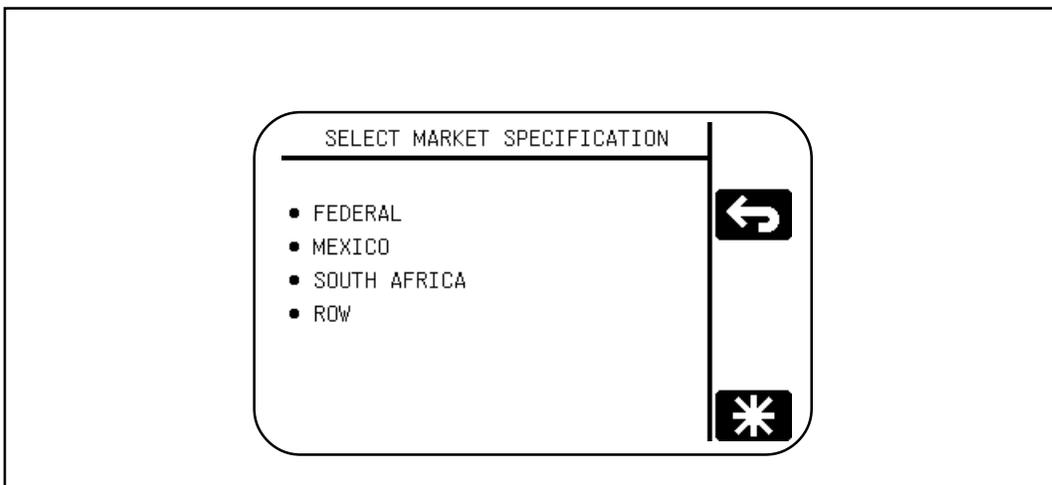
ILLUSTRATION 3

7. Select the market specification "FEDERAL" for US and Canadian vehicles.

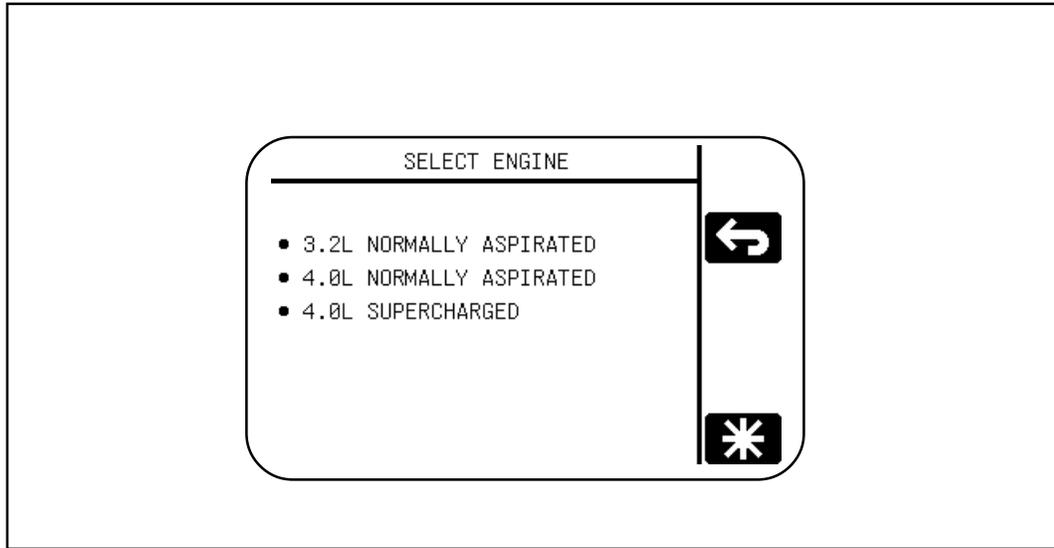
ILLUSTRATION 5

8. Select the engine variant "4.0L NORMALLY ASPIRATED". **Do not select supercharged.**

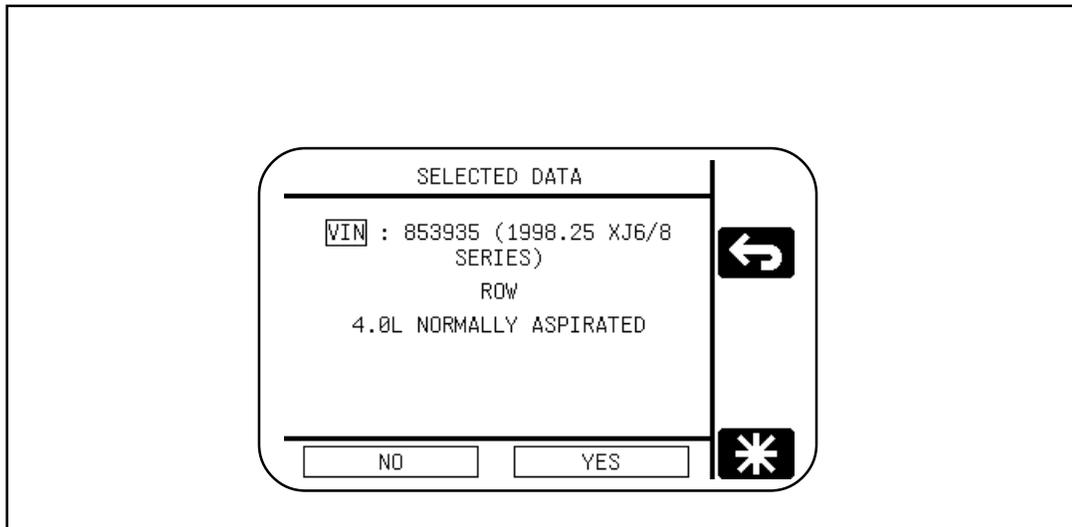
ILLUSTRATION 5

9. Confirm the selected data (example only)

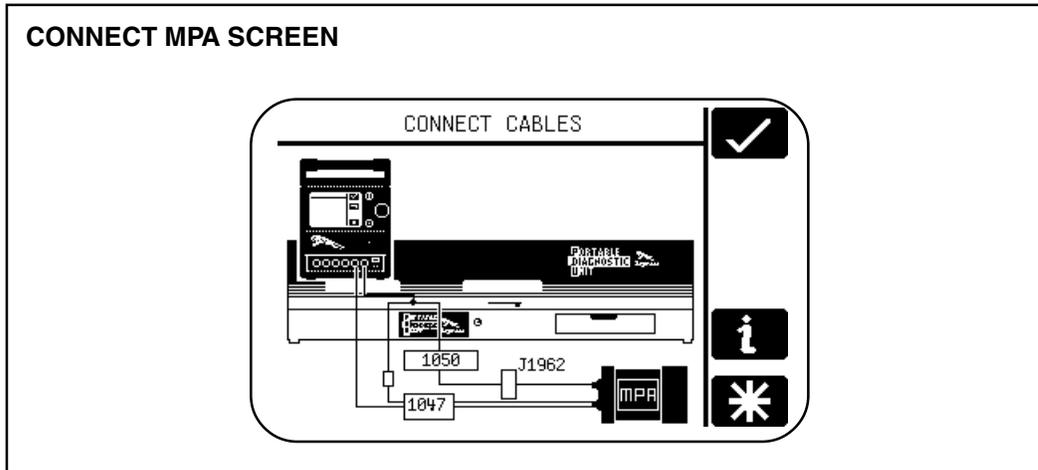
ILLUSTRATION 6

6. When the ‘**Connect Cables**’ command (Illustration 3) appears, connect the MPA to the PDU.
Select the check icon. The PDU will initiate the MPA.

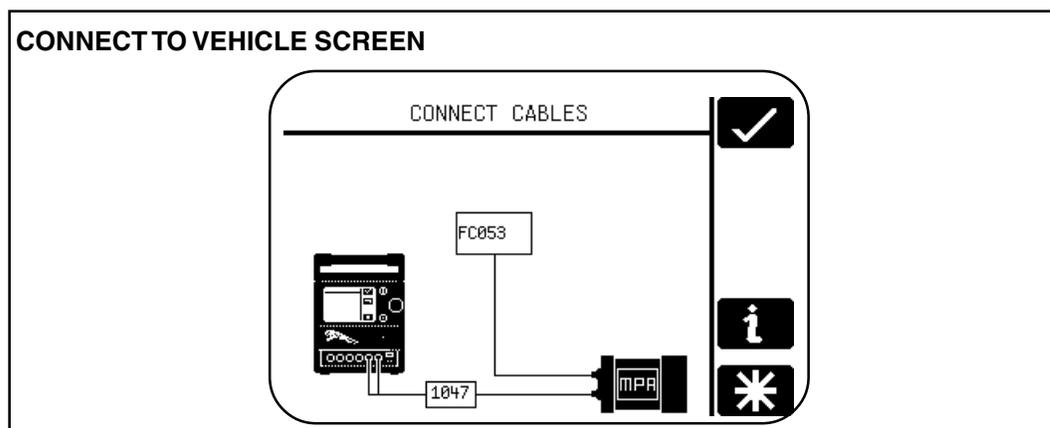
ILLUSTRATION 5

7. When the ‘**Connect Cables**’ command appears, connect the MPA/PDU to the vehicle diagnostic link connector (Illustration 5). The application then checks the Engine Coolant Temperature (ECT) and the Intake Air Temperature (IAT) to ensure they are both below 50°C before allowing the application to proceed.
If either of the two temperatures are above 50°C, the temperature would be displayed on the PDU screen along with the message, ‘**Both temperature sensors must read between 0 and 50 degree Celsius to continue; press TICK to abort.**’ (Tick = check icon). After aborting, the application would return to the Main Menu.

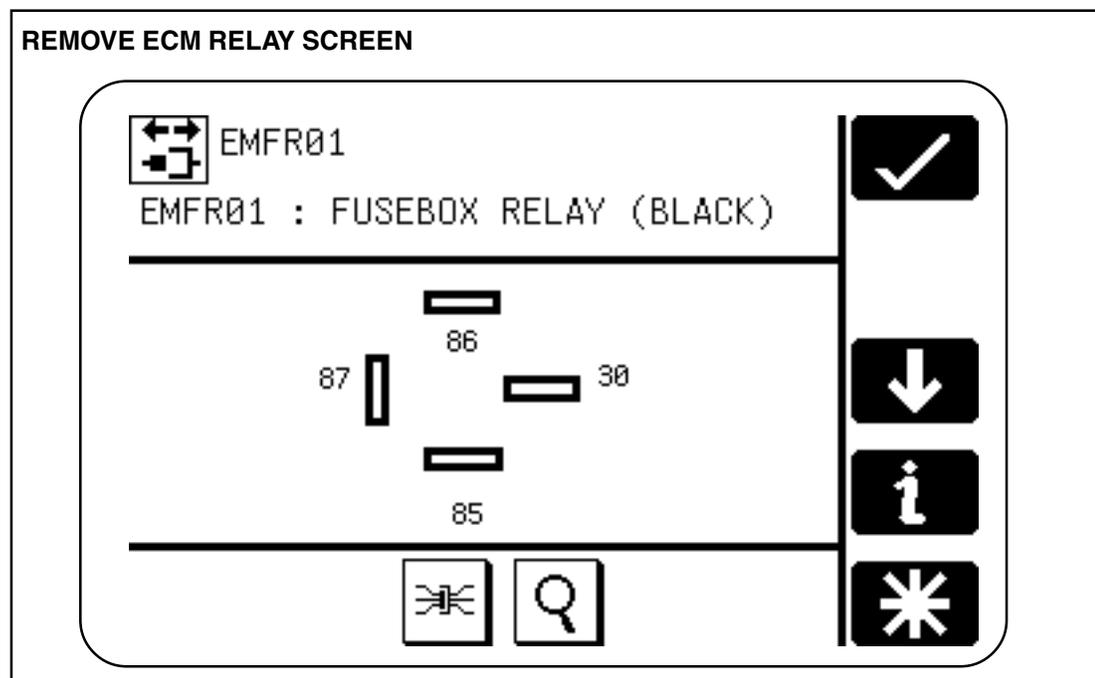
ILLUSTRATION 6

9. The application then indicates that the ECM relay (EMFR01) must be removed (Illustration 6). The Vehicle Data Viewer (VDV) display (select magnifying glass) will show the location of the relay. On XK8 vehicles, the relay is located directly in the engine management fuse box, in front of the ECM in the coolbox. On V8 XJ Series the relay is located in the engine management fuse box on the left front fender.

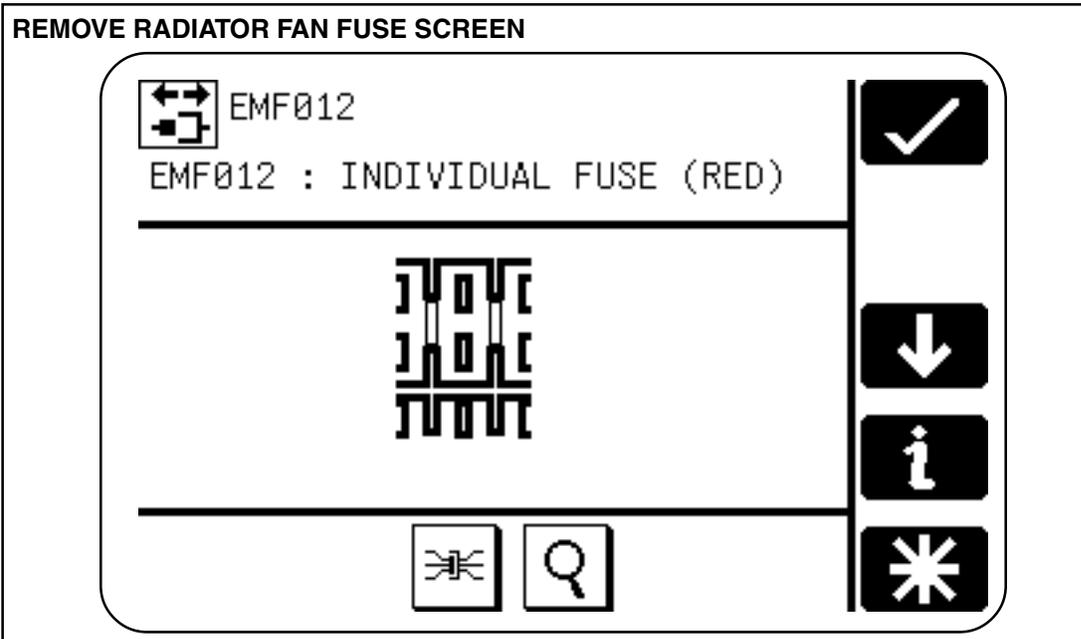
ILLUSTRATION 7

- The application then indicates that the fuse (EMF012 for XK8, EMF014 for V8 XJ Series) for the radiator fan module must be removed (Illustration 7). The VDV display will show the location of the fuse. Engine management fuse box fuse no. 12 (10 Amp) for XK8. Engine management fuse box fuse no. 14 (10 Amp) for V8 XJ Series.

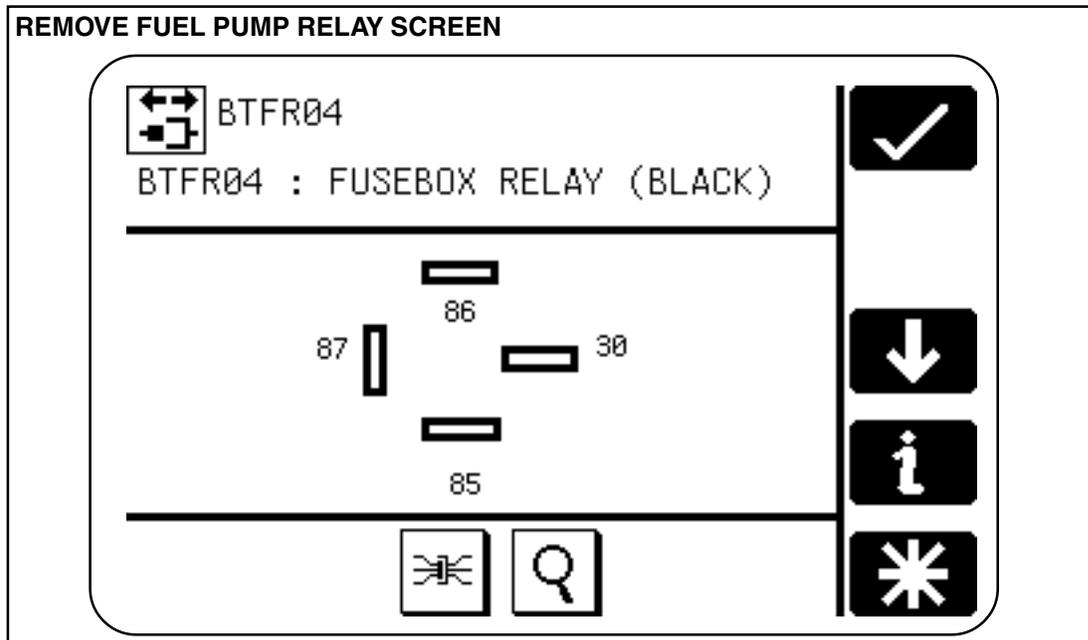
ILLUSTRATION 8

- The application then indicates that the fuel pump relay (BTFR04) must be removed (Illustration 8). The VDV display will show the location of the relay. The relay is located in the trunk fuse box.

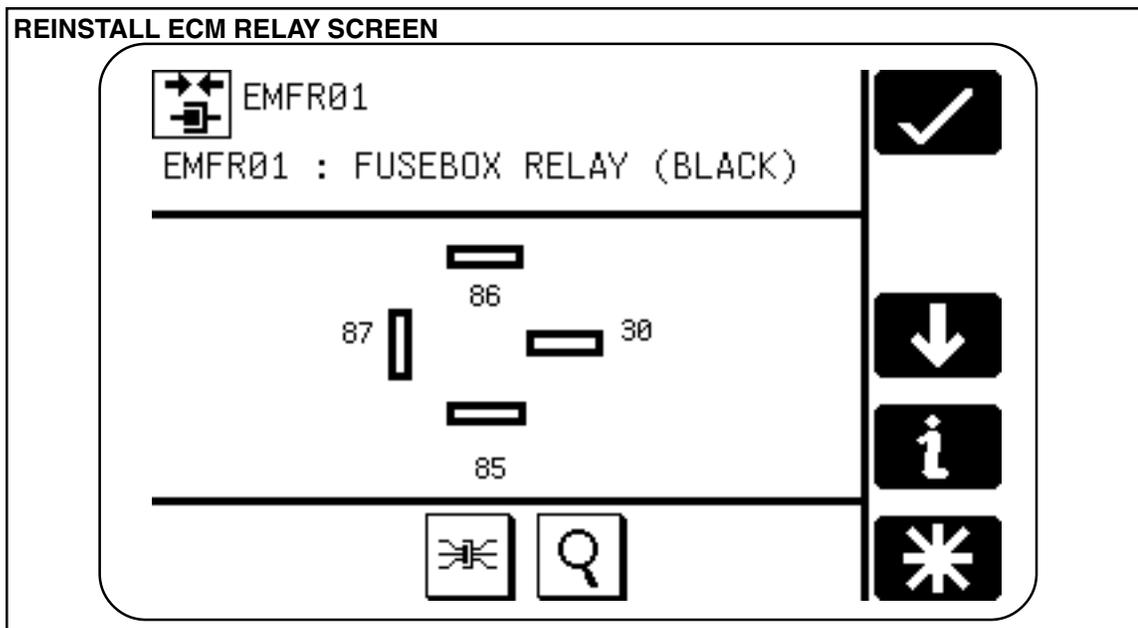
ILLUSTRATION 9

12. The application then indicates that the ECM relay (EMFR01) must be reinstalled (Illustration 9).

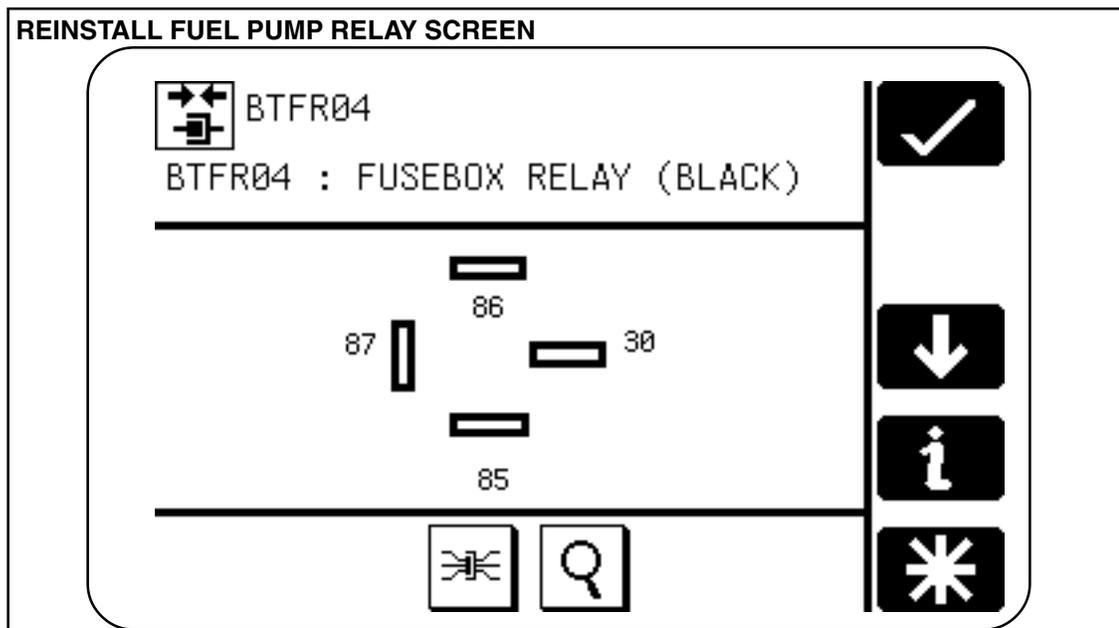
ILLUSTRATION 10

14. The application then indicates that the fuel pump relay BTFR04 must be reinstalled (Illustration 10).

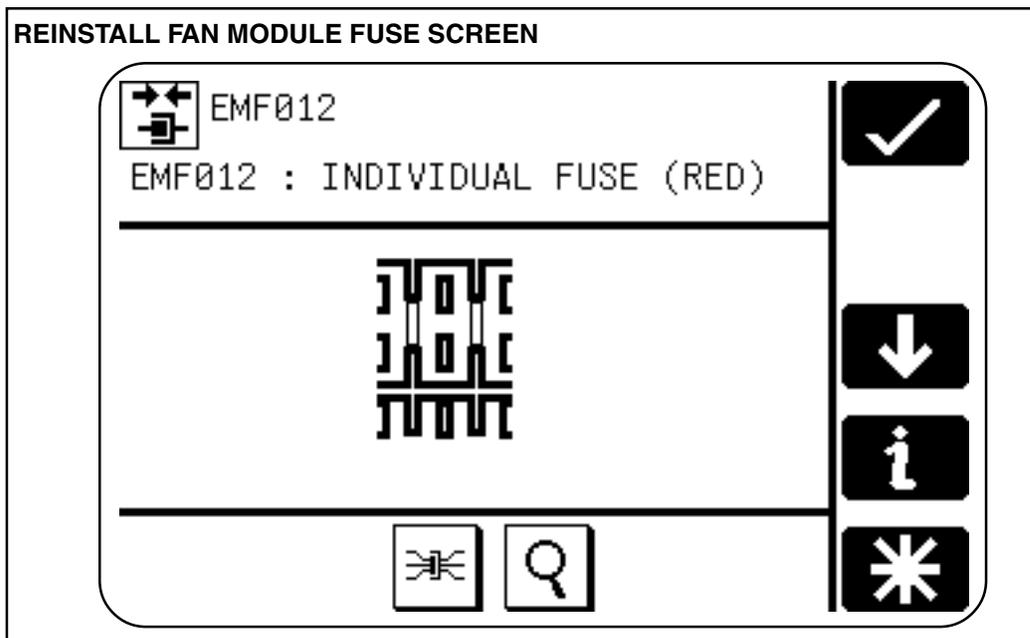
ILLUSTRATION 11

- The application then indicates that fuse for the radiator fan module (EMF012 for XK8, EMF014 for V8 XJ Series) must be reinstalled (Illustration 11).

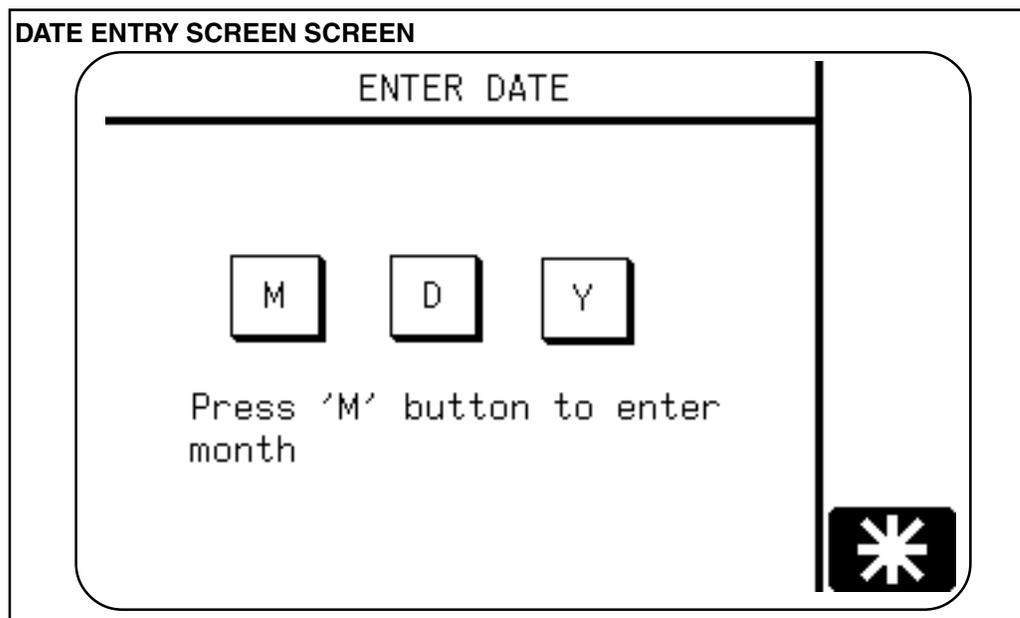
ILLUSTRATION 12

- Once the download is completed and verified, insert the date (Illustration 12), which must be entered in the Federal format, MM/DD/YYYY, using the full four figure year input (such as April 2, 1999 = 04/02/1999).
- The date together with the VIN number and the old and the new flash version numbers, read from the ECM, must be printed out and retained in the vehicle file. Connect the PDU to the multimedia PC as instructed. (The PC must have the PDU-PC Version 3.2 (JTP 628/2) or later software installed. Refer to Administration Bulletins.) Print the trace from the Multimedia PC. Then reconnect the PDU to the MPA and the vehicle as instructed.
