**Selector Lever Cable –
Adjustment Procedure –
Not In Workshop Manual**

MODEL 1997 MY-ON
XK8 Range
VIN
001001-ON

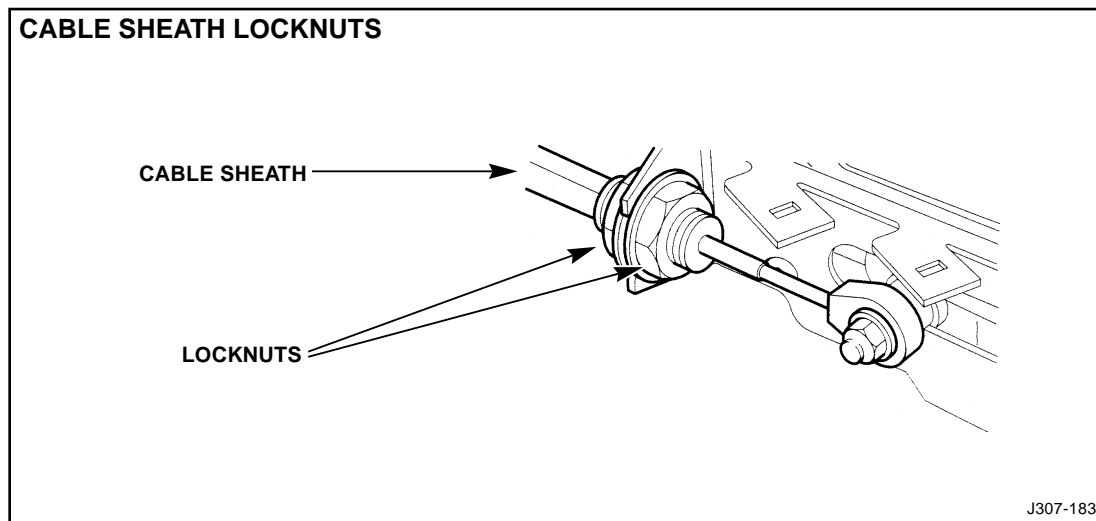
ILLUSTRATION 1

The cable is adjusted by moving the locknuts that secure the cable sheath to the J-gate assembly. This movement will lengthen or shorten the effective length of the cable sheath between the J-gate and the anchorages of the cable sheath.

1. Position the vehicle on a suitable lift.
2. Switch the ignition ON.
3. Depress the service brake pedal to release the interlock, then select N (neutral.)
4. Switch the ignition off and release the brake pedal.
5. Remove the J-gate surround, console finisher and the console.
6. Loosen the locknuts (Illustration 1) of the selector cable sheath and move them to the outer ends of the thread to allow the maximum movement of the sheath in the anchorage bracket.

12. Adjust the cable sheath locknuts until they contact the anchorage bracket.
13. Check that the selector lever is centered in the N position on the J-gate (small amount of clearance forward and rearward.)

14. Use two wrenches to tighten the locknuts equally to ensure that the cable sheath is not disturbed.
15. Recheck the selector lever for free movement within the N position. Adjust if necessary.

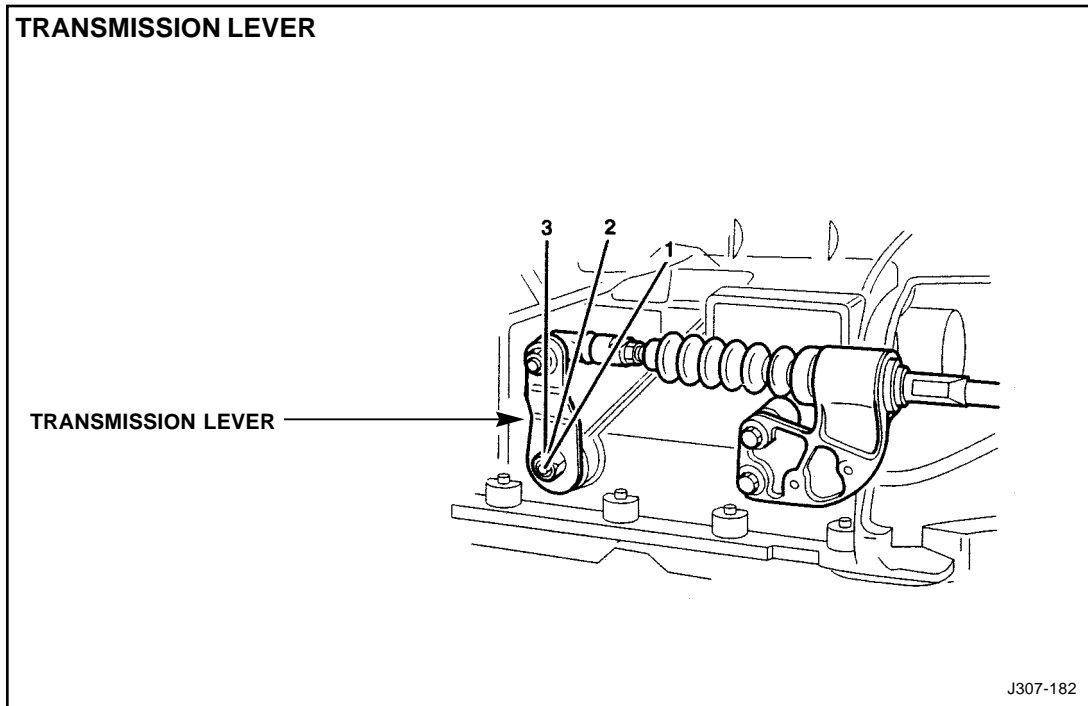
ILLUSTRATION 2

7. Raise the vehicle.
8. Loosen the nut (Illustration 2) that secures the ball pin in the transmission lever. Remove the pin from the lever.

9. Move the transmission lever to the extreme rearward position (position 1, Illustration 2). Then move the transmission lever forward by 2 detents to position 3, Illustration 2, to confirm the true position of N (neutral.)

10. Reinstall the ball pin in the transmission lever, reinstall the locking nut and tighten the nut to 7 to 10 Nm (5.2-7.4 lb ft [62-88.5 lb in])
11. Lower the vehicle.
