S310-S515

TECHNICAL BULLETIN

Fuel Filler Cap Seal Durability –
Revised Seal Ring –
Service Action S515

MODEL 2005 MY
S-TYPE

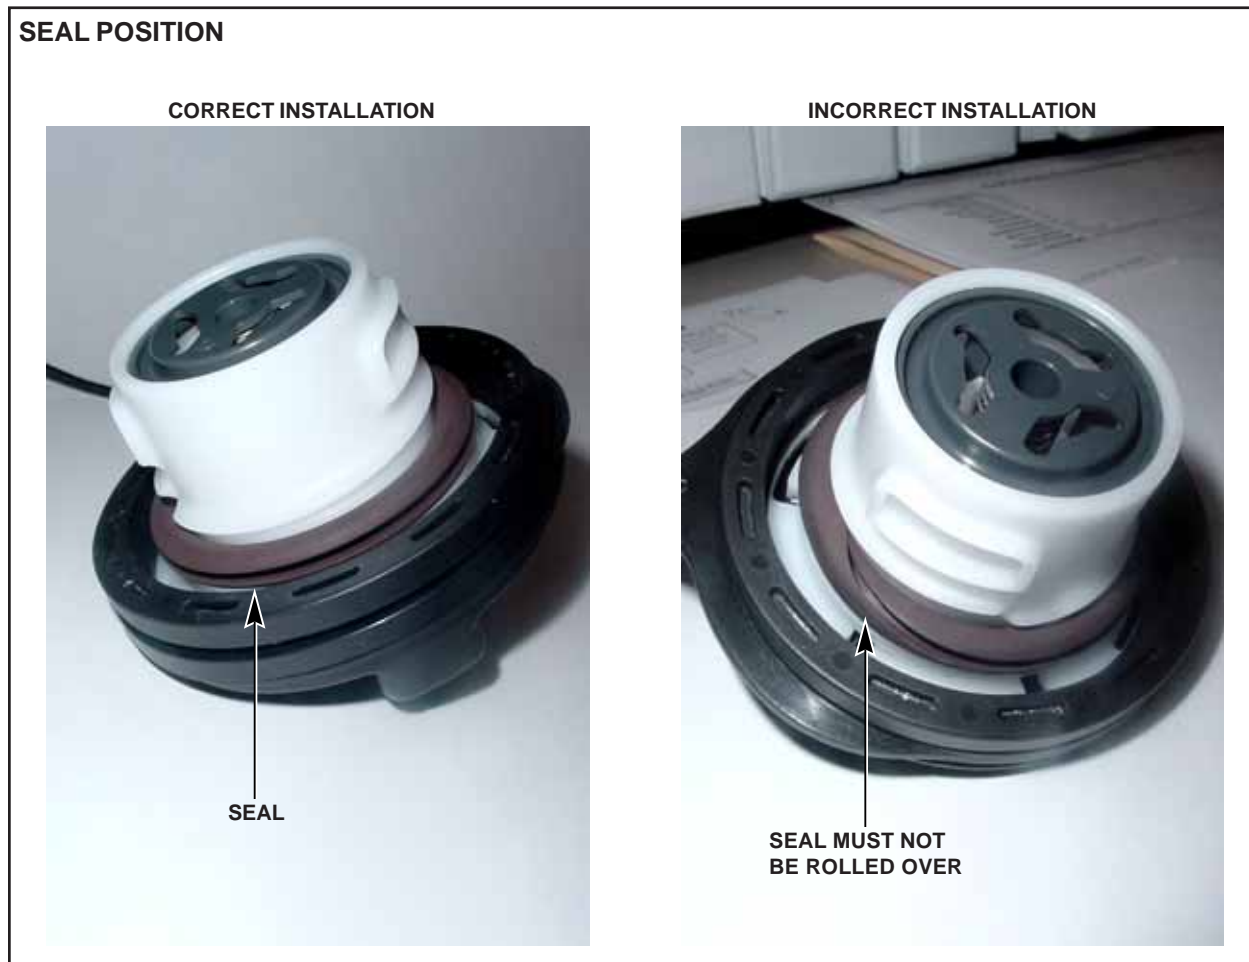
ILLUSTRATION 1

A concern has been identified on a small number of 2005 MY S-TYPE vehicles. The fuel tank filler cap seal is soft and does not provide an adequate or durable seal, resulting in fuel vapor escaping and illumination of the Malfunction Indicator Lamp (MIL) on the instrument panel.

1. Open fuel filler flap.
2. Unscrew fuel filler cap.
3. Remove seal using a suitable pick.
4. Install fuel filler cap seal. Make sure that the seal is fully seated and that the seal is not twisted.

5. Install and tighten fuel filler cap.
6. Close fuel filler flap.
