S-TYPE

TECHNICAL BULLETIN

Rain Sensing Wipers –
Remove Diode/Install 5 Amp Fuse –
Service Action S164

MODEL 2005 MY
S-TYPE
VIN N13089-N25488

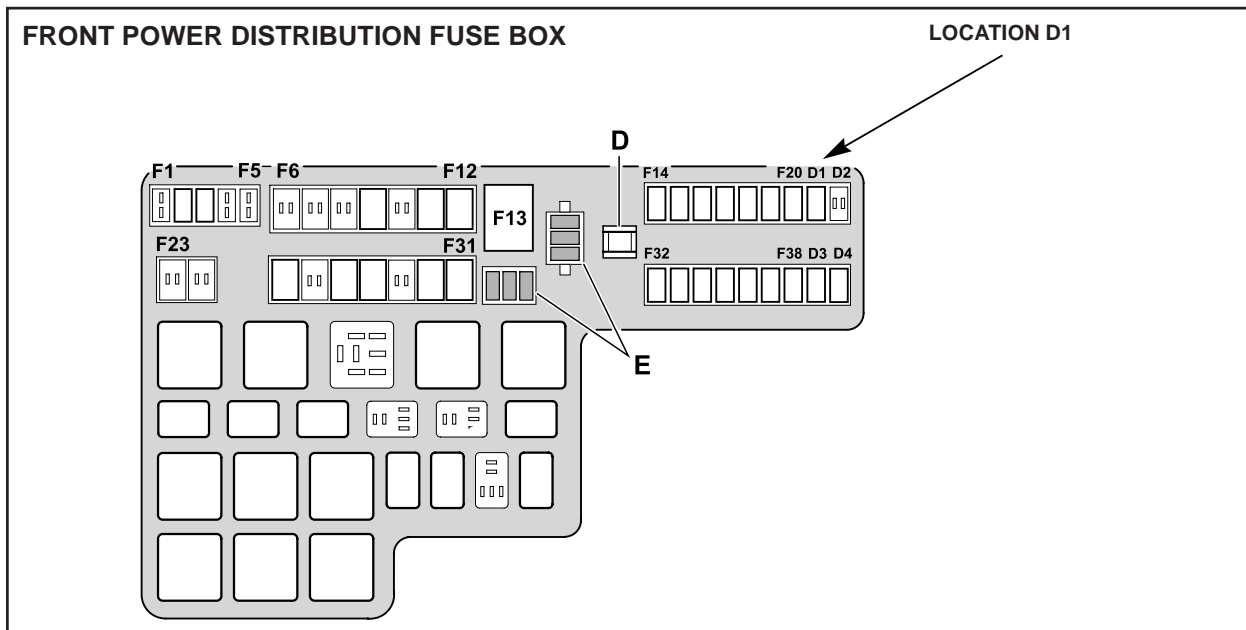
ILLUSTRATION 1

A concern has been identified on a number of 2005 S-TYPE vehicles within the above VIN range. Vehicles equipped with rain sensing wiper control may mistakenly have a diode installed in location D1 of the front power distribution fuse box (located in the engine compartment) instead of the 5 amp fuse that should be in this location.

If a diode is present in location D1, Illustration 1, replace it with a 5 amp fuse. If a 5 amp fuse is present, no further action is required.
