Engine Oil Leak Misdiagnosis –
Vehicles With Automatic Transmission –
Guidelines

MODEL 2002 MY-ON
X-TYPE

VIN C00001-ON

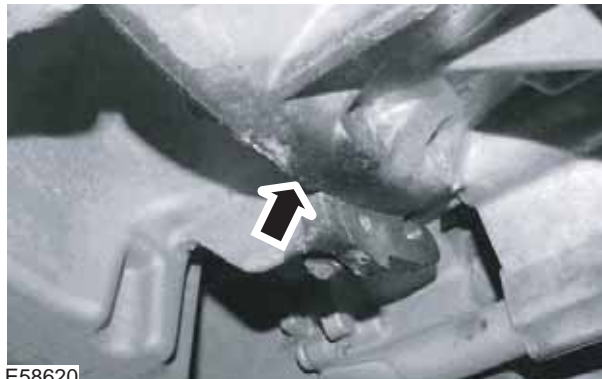
ILLUSTRATION 1

1. Using a suitable cleaner, clean the wax/oil from the torque converter housing/sump area, then road test the vehicle, and recheck for the oil leak.
2. Refer to Illustration 1 for the appearance of torque converter wax (with no engine oil leak).

TORQUE CONVERTER WAX

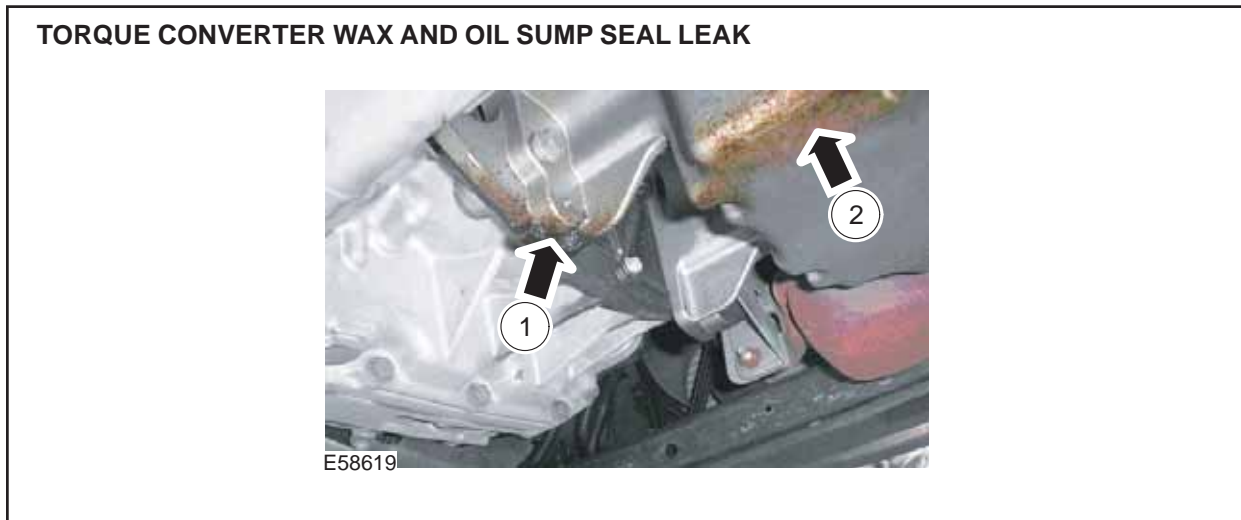
ILLUSTRATION 2

3. Refer to Illustration 2 for the difference in appearance between a torque converter wax (1) and a sump seal leak (2) collecting in the same location.
