MODEL
2007 XK

NUMBER
XK501-001

TECHNICAL BULLETIN

Pre-PDI Activities With Transit Relay Installed

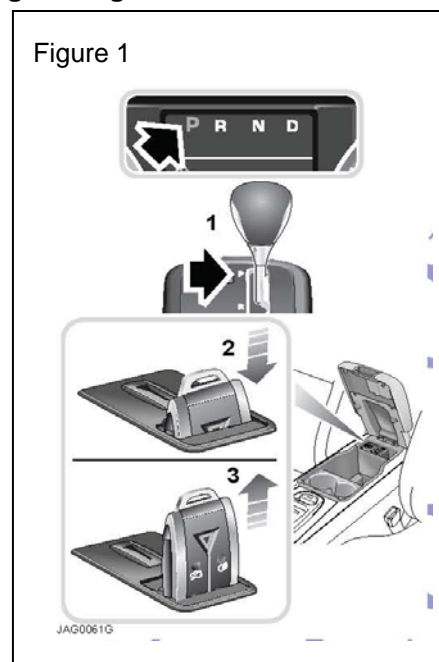
Figure 1

3. When leaving the vehicle ensure the engine has stopped and remove the smart key from the vehicle as follows: (Figure 1)
 - Press downward on the smart key
 - Observe the key self-eject half way
 - Manually remove the smart key from the vehicle

⚠ CAUTION: The smart key must not be forcibly removed or pulled when it is inserted into the slot. The procedure below must be used to eject and then remove the key.
