# TECHNICAL BULLETIN

## Knocking Noise – Rear Subframe Bushing – Modification Procedure

**64-17**

MODEL 1988-94 MY Sedan

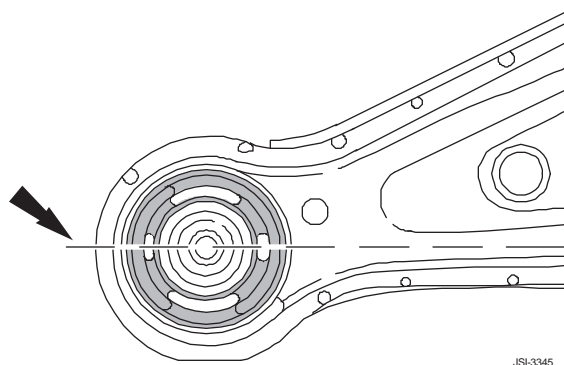
ILLUSTRATION 1

1. Remove the subframe from the vehicle.
2. Press out the old bushings from the subframe and thoroughly clean the bores and the surrounding areas.
3. Place the subframe on a bench and stretch a line or measuring tape through the centers of the two bores, as indicated in Illustration 1, to indicate the centerline.

**CENTERLINE OF REAR SUBFRAME BUSHING**

**Note:** When the bushing is installed the centerline should pass through the center of the two voids in the bushing, as shown in Illustration 1.

- Place small squares of masking tape on the top face of each bore, under the line or tape. Mark the centerline, with pen or pencil, on the masking tape.

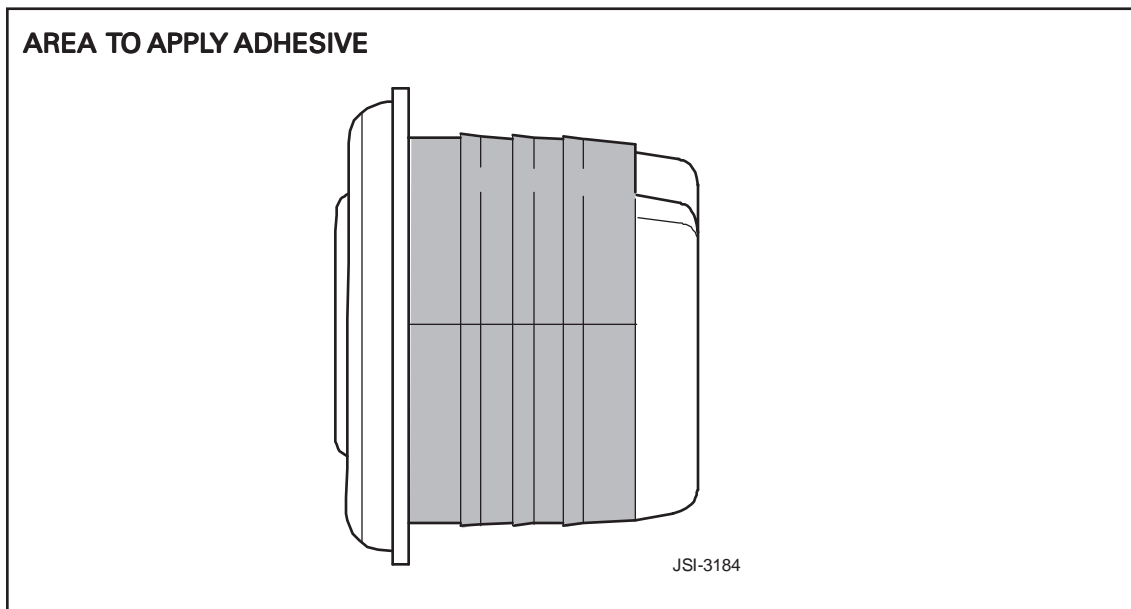
ILLUSTRATION 3

13. Apply the adhesive over the area of the bushing, shown shaded in Illustration 3, and the bore in the subframe.

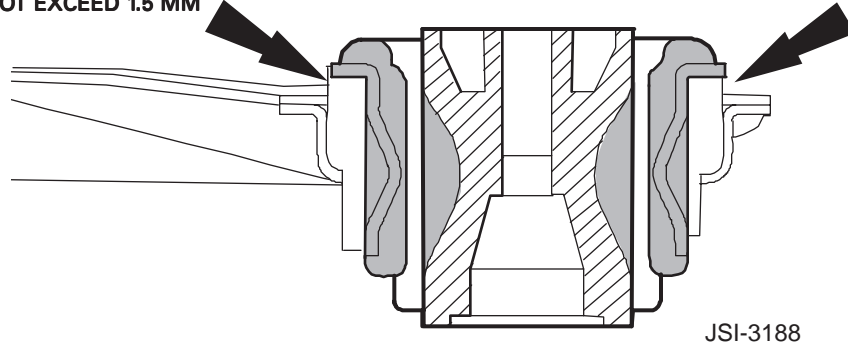
ILLUSTRATION 4

**POSITION OF BUSHING IN SUBFRAME**

GAP MUST NOT EXCEED 1.5 MM

17. After the bushing has been inserted in the subframe, check for any clearance between the bushing flange and the subframe, (Illustration 4). If a gap is present, **it must not exceed 1.5 mm.**
18. Repeat the operation for the other bushing.
