Front Wheel Hub – Accumulation Of Excess Grease – Grease Deflector Ring

1997 MY-ON XK8 Range

1998 MY-ON V8 Sedan NA

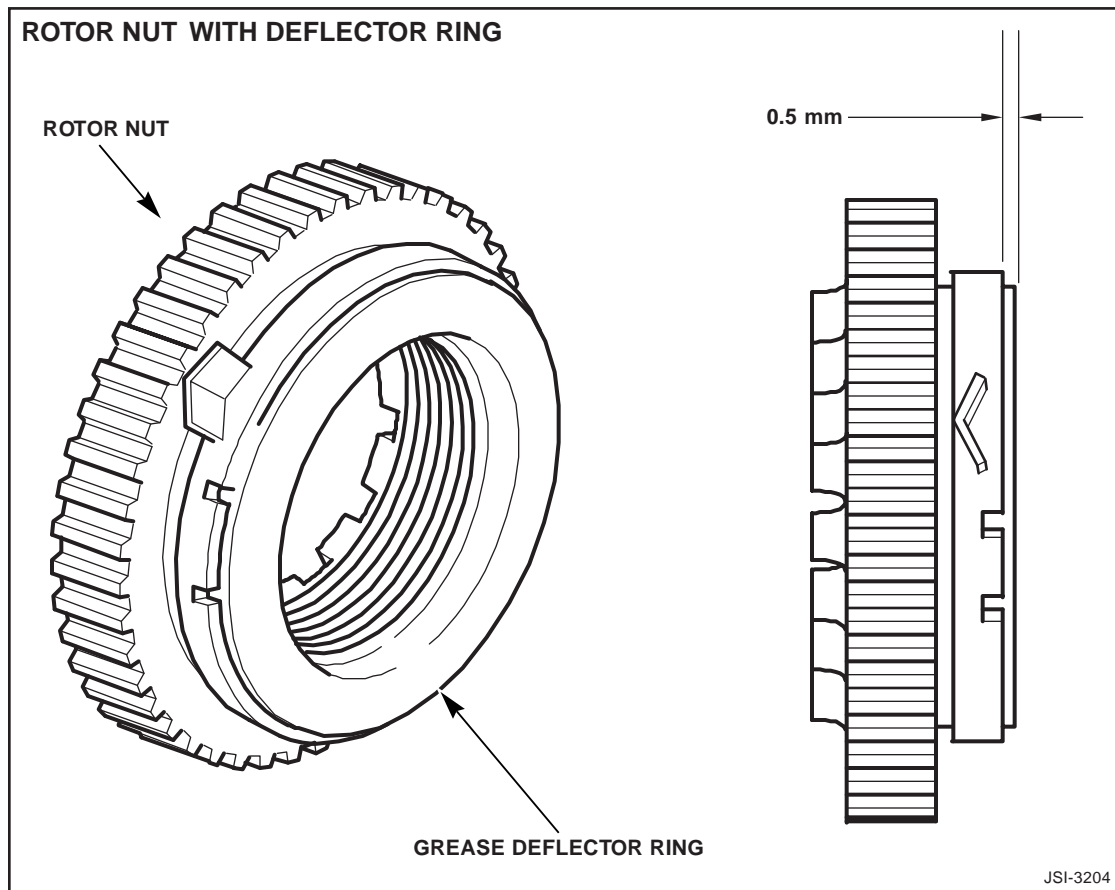
ILLUSTRATION 1

The deflector ring is a light interference fit on the nut and must be installed 0.5 mm from the edge of the hub as shown in Illustration 1.

Vehicles after the above VIN are equipped with a nylon grease deflector ring on the rotor nut of each front hub. This ring prevents the build-up of excess grease near the seal which could collect dirt that could damage the seal.

When performing a repair on a 1997 MY-on XK8 that requires removing the rotor nut, install a grease deflector ring during reassembly. 1998 MY-on vehicles must always have the deflector ring reinstalled during any service to the front hub.
