**Fuel Pipe – Rattle –
Install Pipe Clip****MODEL** 1995 MY
Sedan (4.0l) Range
VIN
720001 - 738089**ISSUE:**

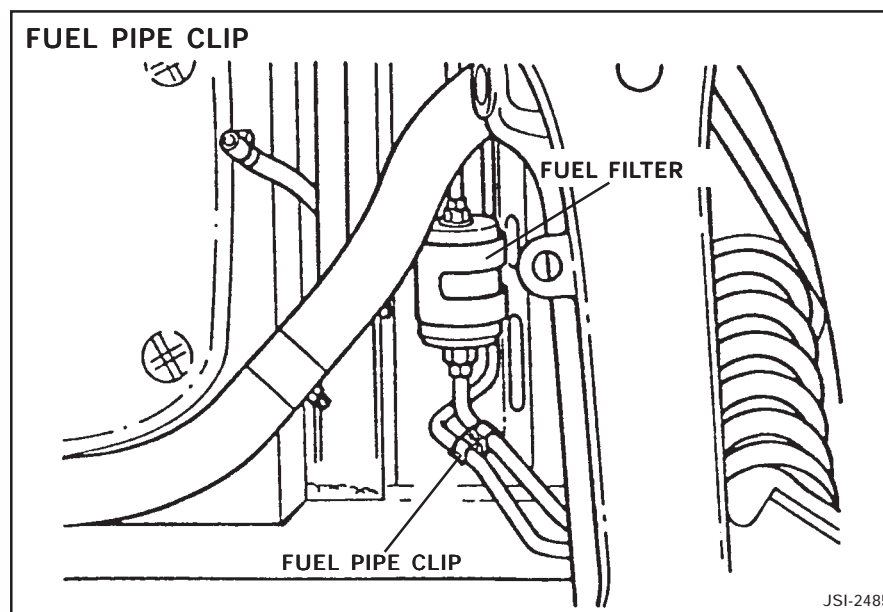
ILLUSTRATION 1

1995 MY Sedan Range vehicles within the VIN range above may experience a light rattle from the rear. The rattle occurs at idle with the vehicle stopped. A plastic fuel pipe clip was installed in production at VIN 738090 to stabilize the fuel pipes and prevent the possibility of a rattle.

1. Check the alignment of the fuel feed and return pipes near the fuel filter. The fuel pipes must not come into contact with any body member or adjacent pipes.
2. Install a plastic pipe clip (part number KDG 108104) between the fuel pipes as shown in Illustration 1.
