CD Autochanger – Transit Screws –  
Storage Location

MODEL 1995-96 MY  
Sedan Range  
VIN  
720001-ON

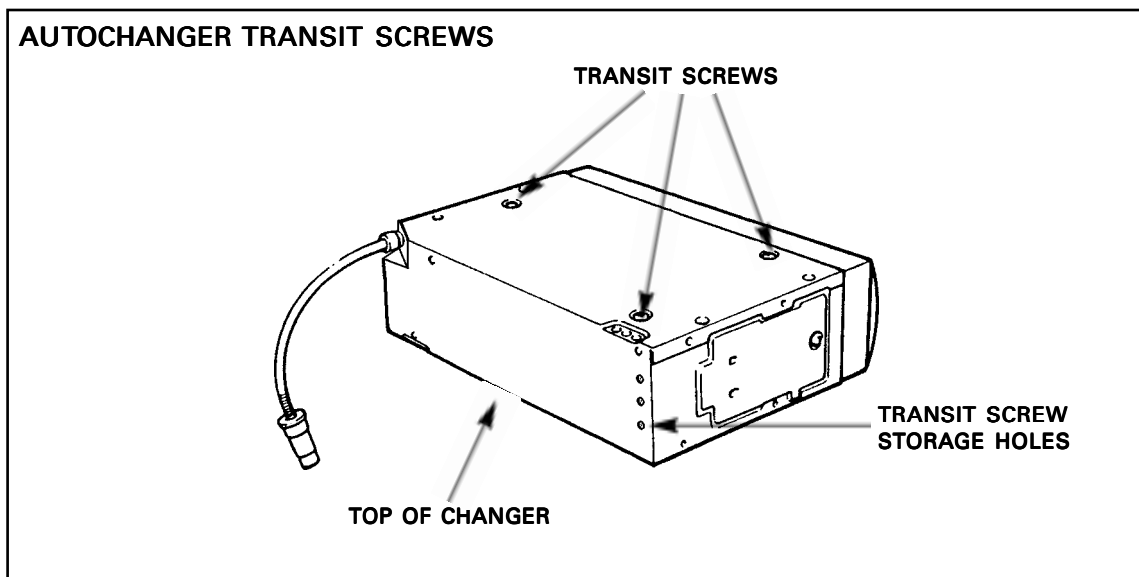
ILLUSTRATION 1

Starting with VIN 787300, these screws should be placed in the storage holes now provided on the rear face of the unit.

The storage location is shown in Illustration 1.

When removing the CD Autochanger for repair or replacement, **reinstall all three** transit screws into the three holes on the bottom of the unit, before the Autochanger is packed for shipping.

**NOTE:** Correct installation of **all three** transit screws is essential to prevent damage to the mechanism during shipping.
